Dunedin City Lifelines Project Report

DUNEDIN CITY LIFELINES PROJECT REPORT

December 1998

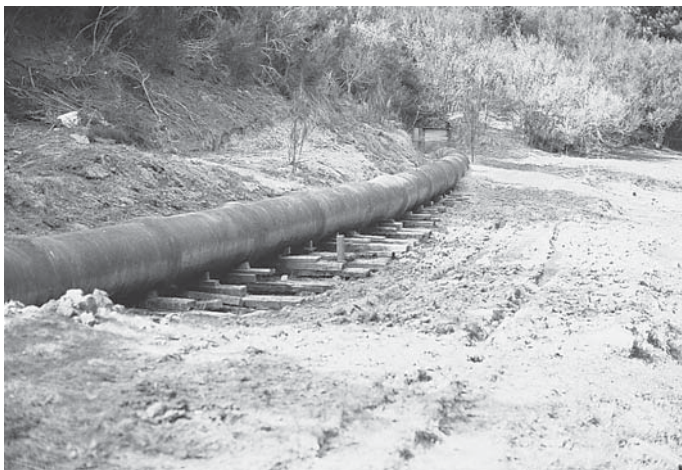
Silverstream Pipeline, showing jacking up - Civil Defence

The aged road bridge which supports the pipeline over the Silverstream at Wingatui Road is another vulnerable point on the supply line and the section from Wingatui Treatment Station along the Silverstream pipeline is continually damaged by land movement with the concrete pipe having to be frequently jacked up and rejointed following ground settlement.

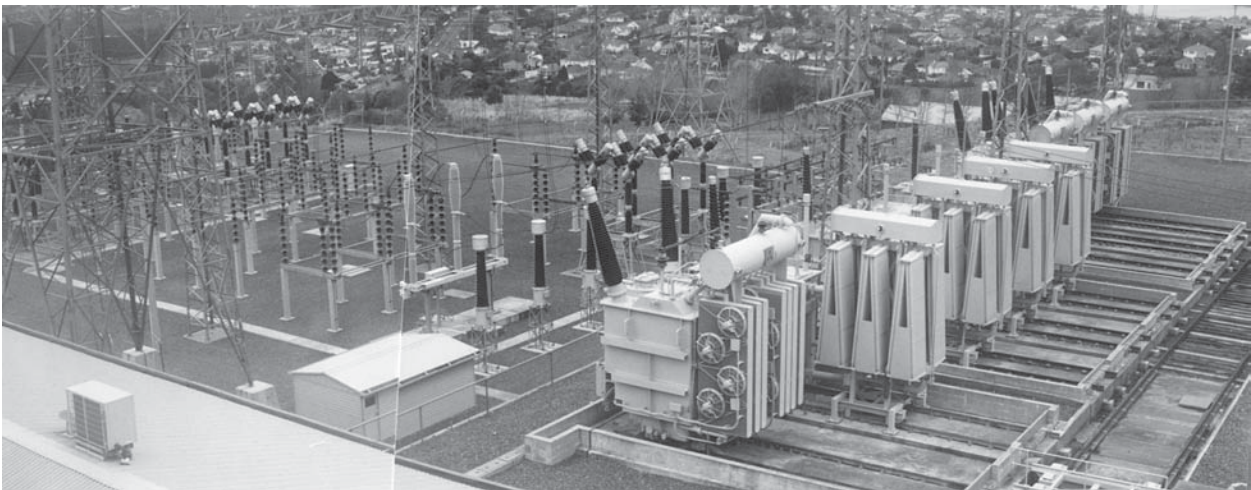
Transpower Halfway Bush Substation - Transpower Limited

Although newer items should be able to withstand 1.5g, which equates approximately to a maximum credible seismic event, older items could well fail. Studies of similar substations after major earthquakes, eg in California, tend to confirm this. As part of Transpower's on-going upgrading programme, three more circuit breakers have been upgraded recently.

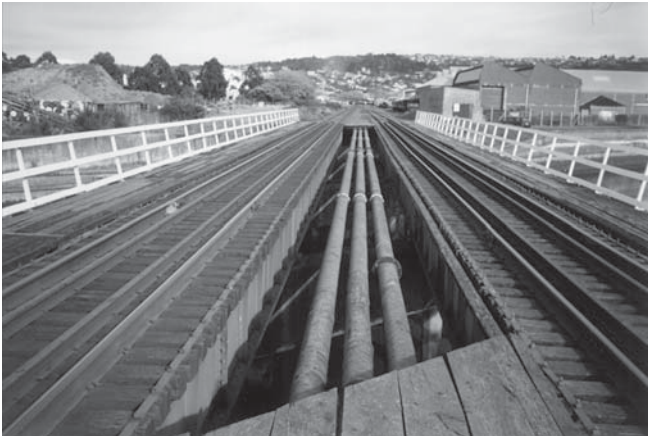
Oil Pipelines from Oil Wharf to Storage Tanks Crossing Leith Rail Bridge - BP Oil Limited

Potential damage may occur to pipelines crossing the Leith Bridge which is a common carrier for other service pipelines. Any failure here will almost certainly be fracturing of the pipelines due to bridge displacement rather than to inherent pipeline condition.

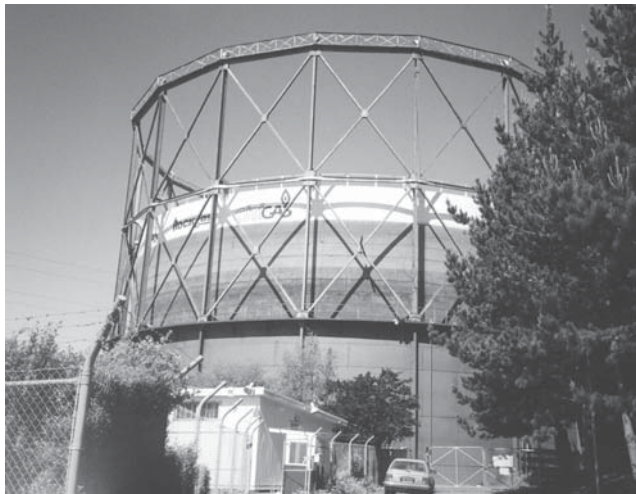
Kensington Gasometer - Citigas Limited

It is therefore difficult to present a case for other than replacement of significant lengths of pipeline, particularly as most sections of the principal gas main have no redundancy. It is considered, however, that progressive replacement of the most vulnerable elements may be a more acceptable course of action. Indications are that the 400mm diameter main line from the tempering plant to the Kensington gasometer, and the gasometer itself need priority treatment.

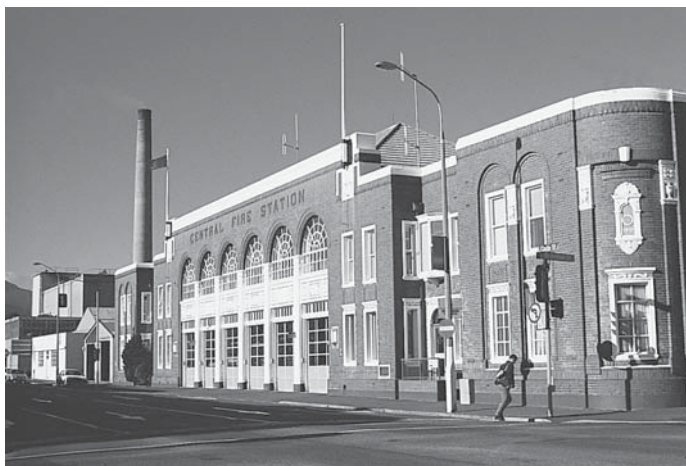
Dunedin Central Fire Station - Civil Defence

This building, although including reinforced and steel elements, is essentially of unreinforced masonry. It is likely to suffer severe damage appliances housed within the building may be damaged or trapped. There is also a risk to personnel.

Though the vulnerability of the building is recognised by the NZ Fire Service and there are contingency plans for control of emergencies from elsewhere (St John Ambulance, Central Police Station), the security of this facility itself is nevertheless critical.
