4 Transportation

4.1 INTRODUCTION

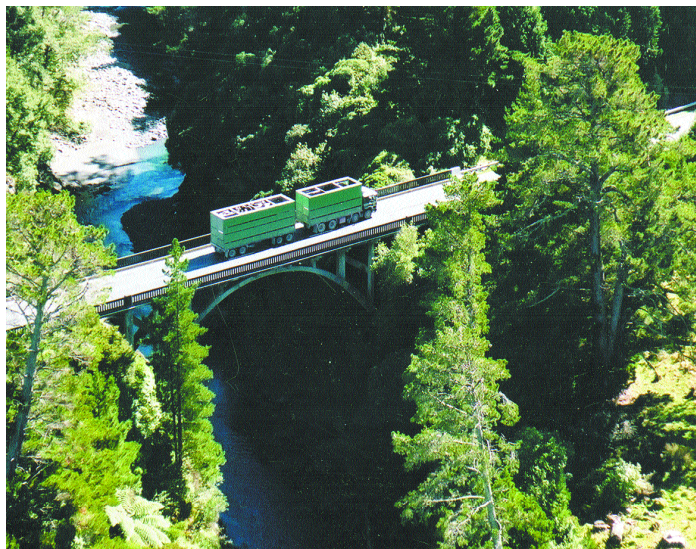
Figure 4.2. Ruamahanga Bridge at Mt. Bruce. This 'arch span' structure is a key component of Wairarapa's road links to the north.

Two major components of the network could have long impacts if they were damaged. These are the Ruamahanga Bridge at Mount Bruce and the Waingawa Bridge. The Waingawa Bridge risk is low, whereas at the Ruamahanga Bridge the risk is high and, to some extent, unknown.

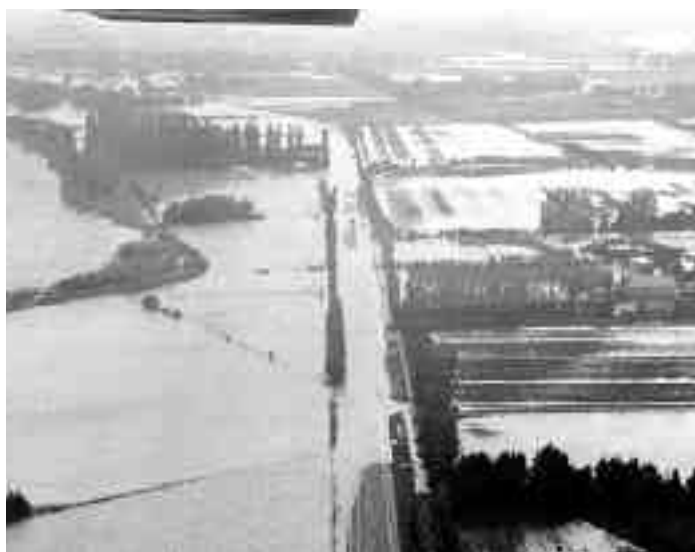
The section from Hodders Road (Waihakeke Road) to North Street in Greytown is subject to flooding. Plans are well advanced by the Wellington Regional Council to alleviate this hazard. While the problem is complex, the main elements are lack of capacity under the Waiohine Bridge and downstream river channel, and the road to spill excess flood waters via the Apple Barrel floodway. Should a major event occur in the meantime, then the scenarios could be damage to the Waiohine Bridge, rupture of the stop banks between the Waiohine Bridge and Kuratawhiti Street, excessive water at the Apple Barrel floodway and overtopping of the state highway between Hodders Road and Mangatere Bridge. **Figure 4.3** shows the Apple Barrel floodway during severe flooding from the Waiohine River.

Figure 4.3. SH2 north of Greytown. View from the Apple Barrel floodway in the foreground towards the Waiohine 'Black Bridge' in the distance. The road was closed in November 1994, due to flooding of the Waiohine River. *Photo courtesy of the Wairarapa Times Age.*

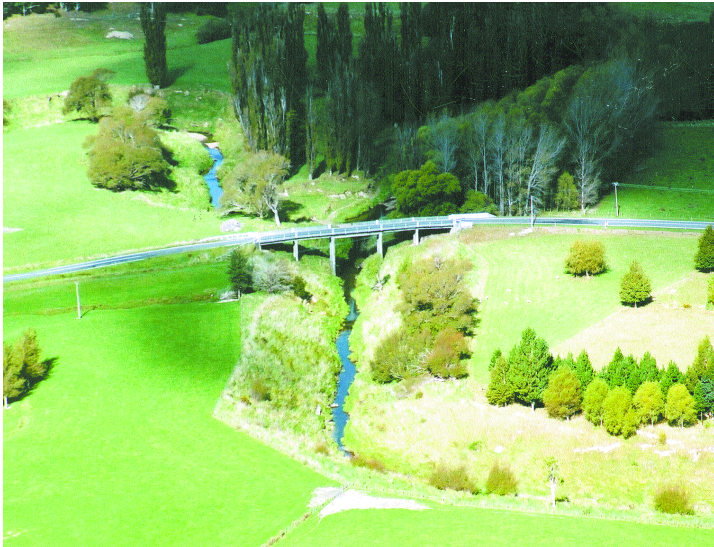
The most extensive zone of undifferentiated flood plain alluvium identified in the Masterton district runs from Annedale Road, down Manawa Road through Tinui and Whareama and down through Homewood Road and Kaiwhata Road. The Tinui Bridge (Figure 4.5) is located in this zone.

Figure 4.5. The Tinui Bridge on the Masterton-Castlepoint Road. This single lane structure is sited on an area of high liquefaction potential.

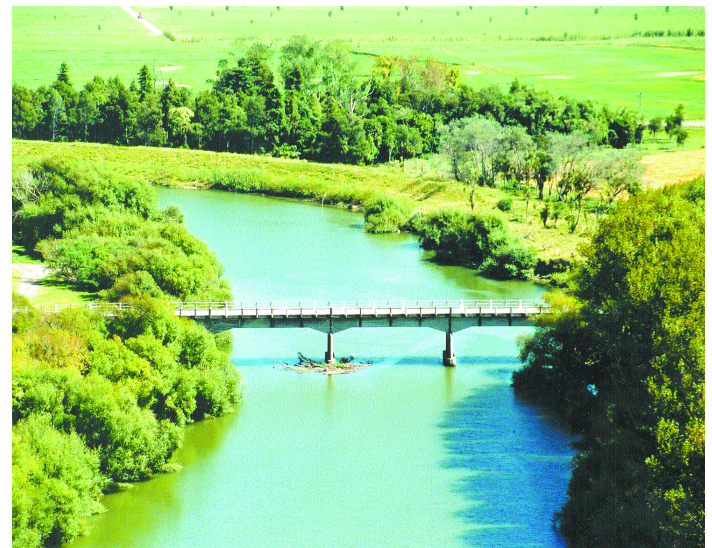
The Tuhitarata Bridge on the Ruamahanga River was damaged by liquefaction and lateral spread in the 1942 earthquake (**Figure 4.6**).

Figure 4.6. The Tuhitarata Bridge over the Ruamahanga River in the South Wairarapa District. Liquefaction damage occurred to this important structure in the 1942 Wairarapa Earthquake.

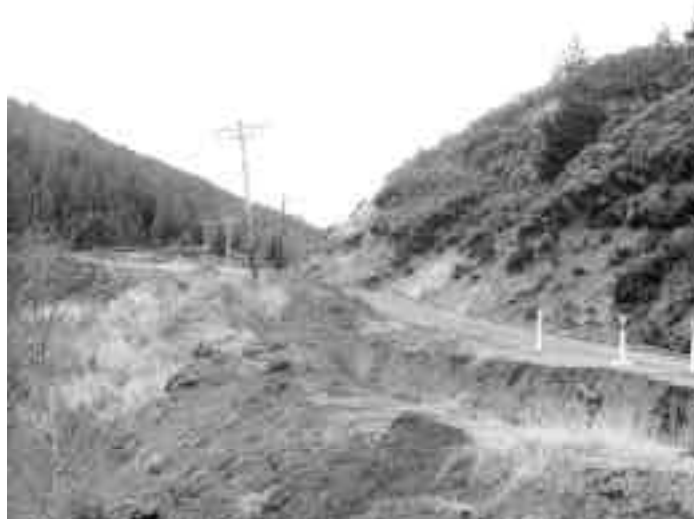
Much of the eastern hill country of the district is very susceptible to landslide. The Masterton-Castlepoint Road is the most vulnerable of the important routes (**Figure 4.7**). Along much of its length the road is benched into the hillside above rivers. This makes it particularly vulnerable to dropout failure when the river is in flood or the subgrade is saturated. Because of the confined working space, reinstatement of the road can be complicated. There are several particularly vulnerable sites between Blairlogie and Tinui.

Figure 4.7. Masterton Castlepoint Road at the Whakataki Saddle. This important route was severely affected by slumping in August 1974.

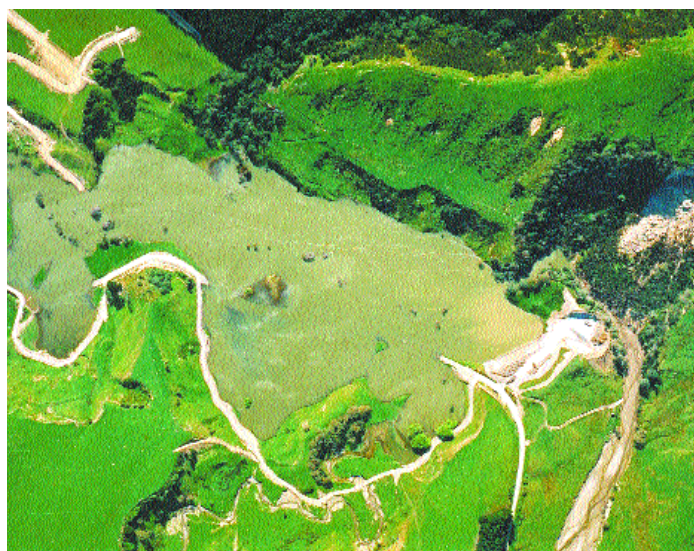
Figure 4.8. Te Ore Ore-Bideford Road, Masterton district. In August 1991, a large landslide, shown above, blocked the stream and the road and bridge were submerged for several months. A temporary route was constructed around the perimeter of the lake.

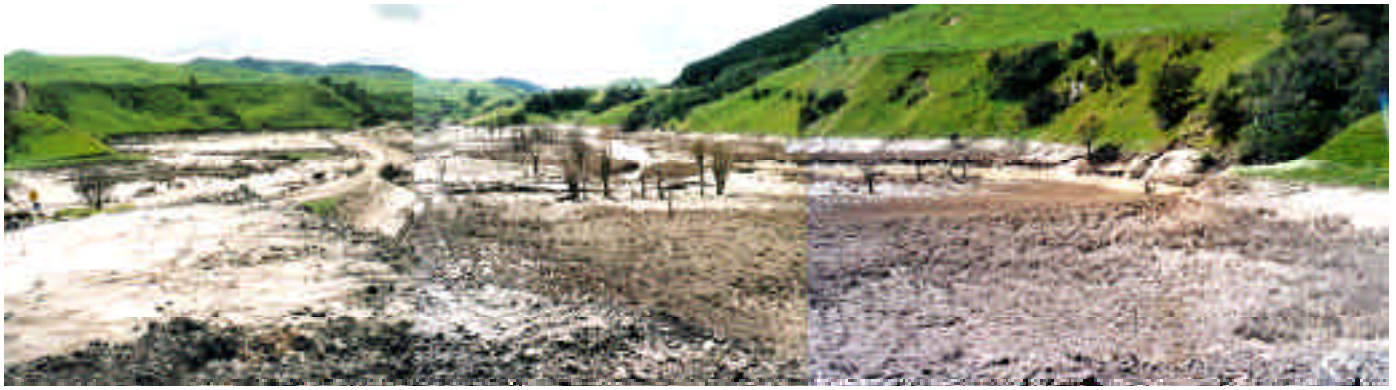
Figure 4.9. Accumulated sediment remaining after draining of the Bideford lake.

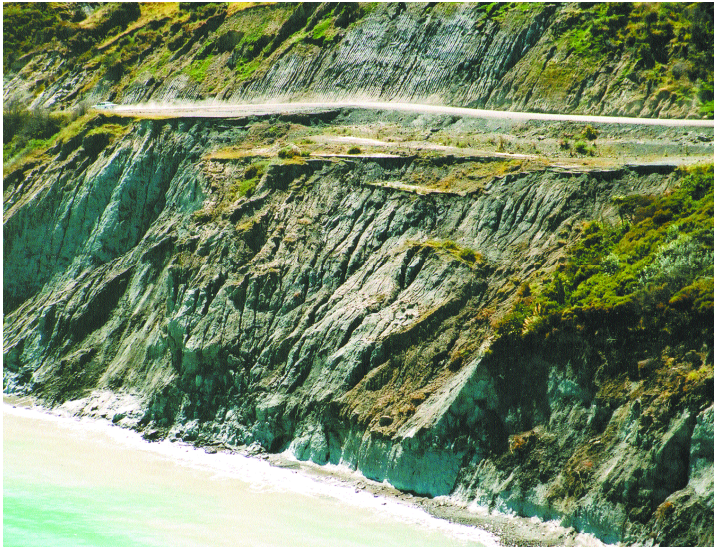
Figure 4.10. Cape Palliser Road at Te Kopi. There is severe instability of the road at this location due to coastal erosion and slumping of the mudstone material. Note the succession of previous road levels below the present road.

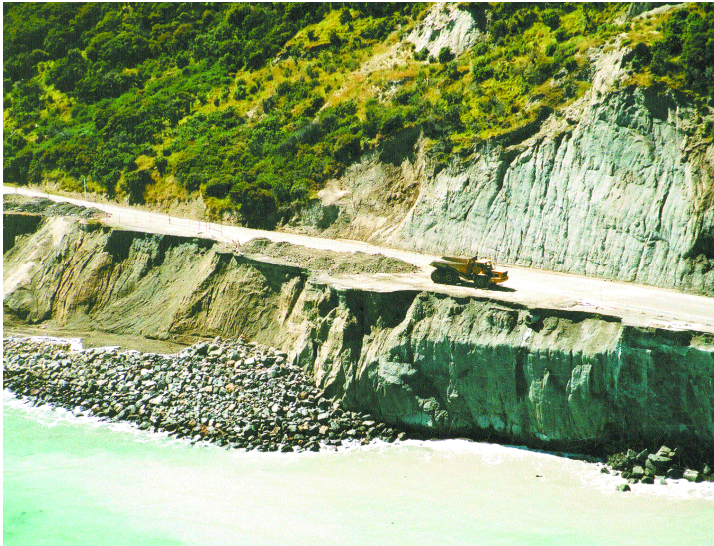
Figure 4.11. Cape Palliser Road at Whatarangi Cliffs. A boulder beach is under construction to counter severe beach erosion.

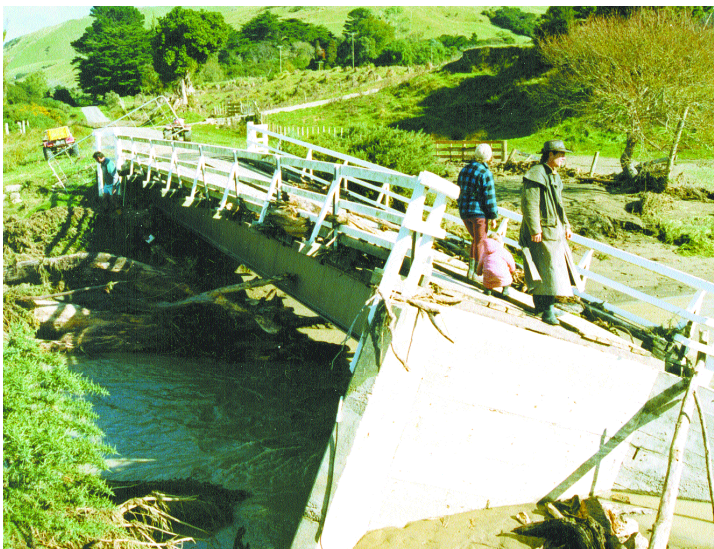
Figure 4.12. Damage to the Packsur Bridge, Mataikona, following scouring and rotating of the abutments in April, 1991.

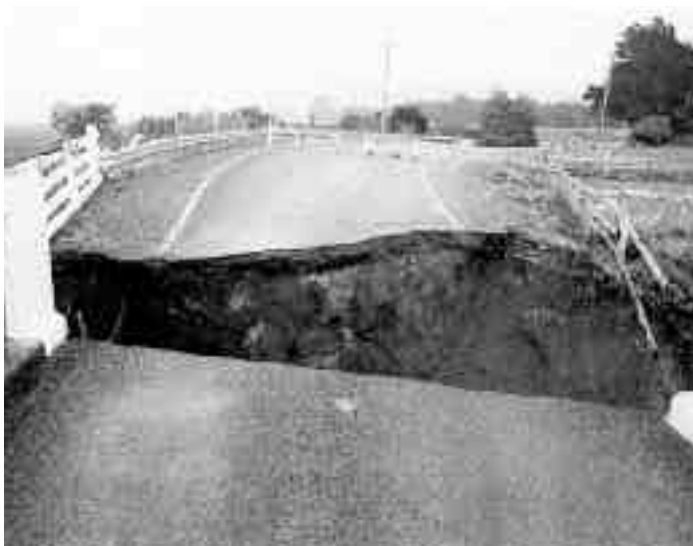
In addition to these areas, Belvedere Road was closed in November 1994 when the western approach to the Mangatarere Bridge failed. (Figure 4.13)

Figure 4.13. Mangatarere Bridge, Belvedere Road, Carterton District. The road was closed in November 1994 when the western bridge approach was eroded. Photo courtesy of the Wairarapa Times-Age.

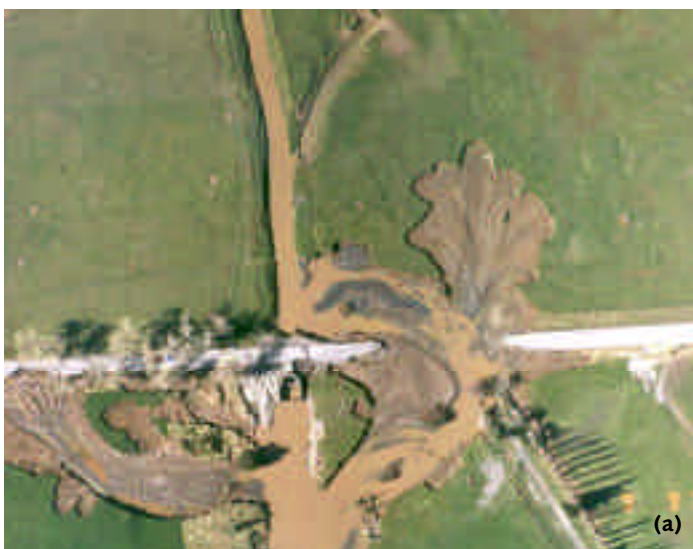
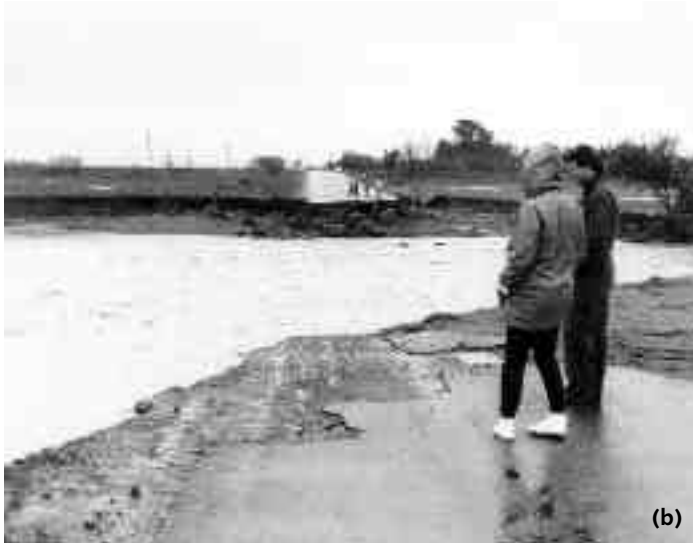
Figure 4.14 a and b. Erosion of the Oporua Floodway and Kahutara Road in the South Wairarapa District occurred in September 1988 and resulted in the need for extensive repair work. Photo (b) courtesy of the Wairarapa Times Age.

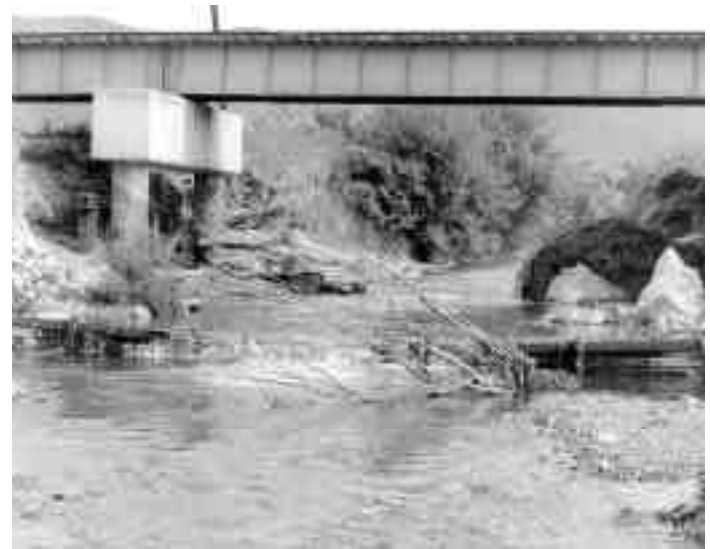
Figure 4.15. The rail bridge at Abbots Creek, Featherston. In November 1975, rockwork and a weir were installed to counter bed-scour at the piers.

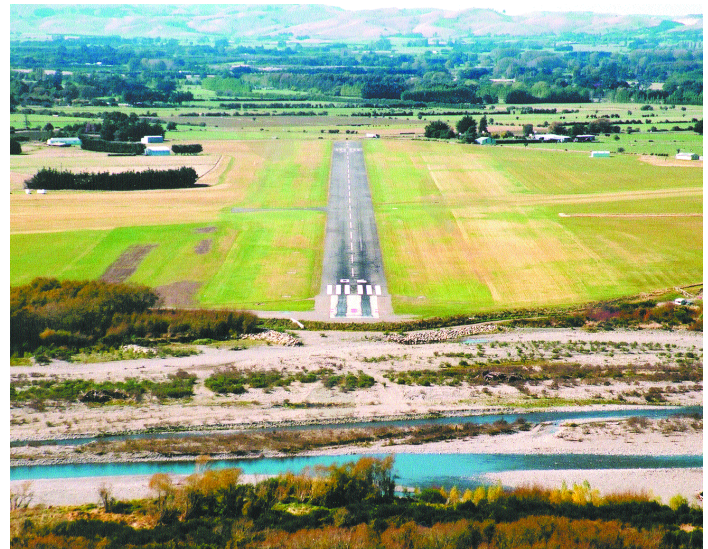
Figure 4.16. Southern end of the Hood Aerodrome runway, Masterton. Severe erosion occurred in 2000, reducing the 'over-run' area and threatening the runway. Extensive river realignment and rip rap protection was required.
