# 6 Critical Facilities

## 6.1 INTRODUCTION

### Masterton Hospital - Structural, non structural, building services and lifelines – summary of vulnerable elements (Inspection carried out October 1997 - April 1998)

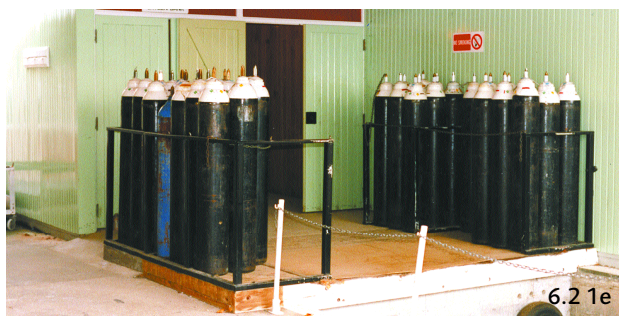
Inadequately restrained gas cylinders at A & E (see Table 6.1)

d Aerials etc.	All items mounted on roof including fixings and base structure.	Check against wind loading in NZS4203.
e Oxygen and medical gases	Full and empty cylinders are inadequately restrained at A&E and Ambulance.	If possible choose a less critical storage and supply station and/or provide robust storage brackets and fixings to restrain full and empty cylinders.
f Patient information services	Patient files in the shelving units could be thrown out in an earthquake and become mixed.	Provide a shelving bar or restraint which allows files to be retrieved in normal use but prevents them being dislodged. Computerise all files.
g Chlorine mixing area for orthopaedic pool	Chlorine storage and mixing area - accident or earthquake could result in the discharge of toxic fumes into the three-storey block forcing evacuation. Chlorine drums and controls not restrained.	Mix in more suitable area - discuss with OSH or Fire Service.

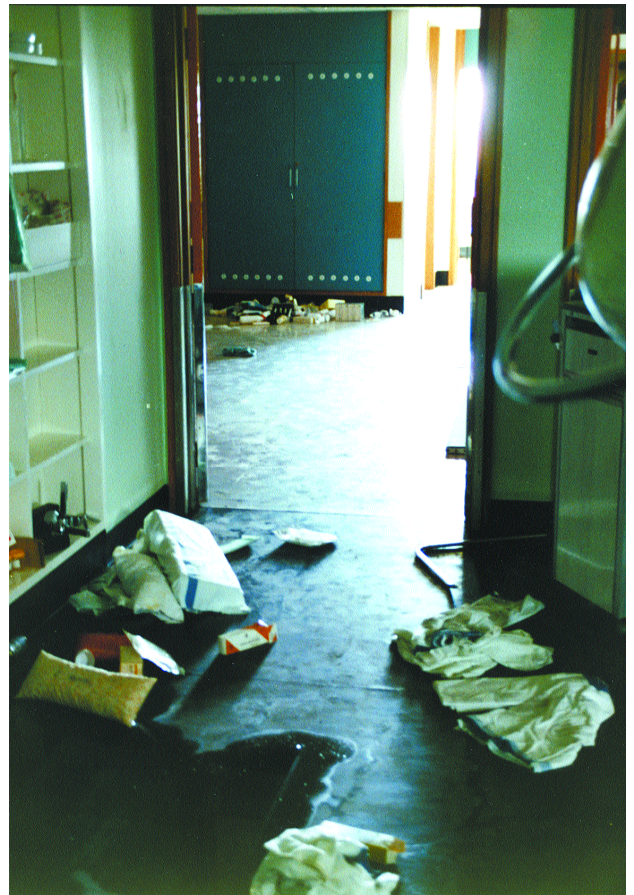
Unrestrained surgical supplies thrown to the ground at Whakatane Hospital during the March 1987 Edgecumbe Earthquake.

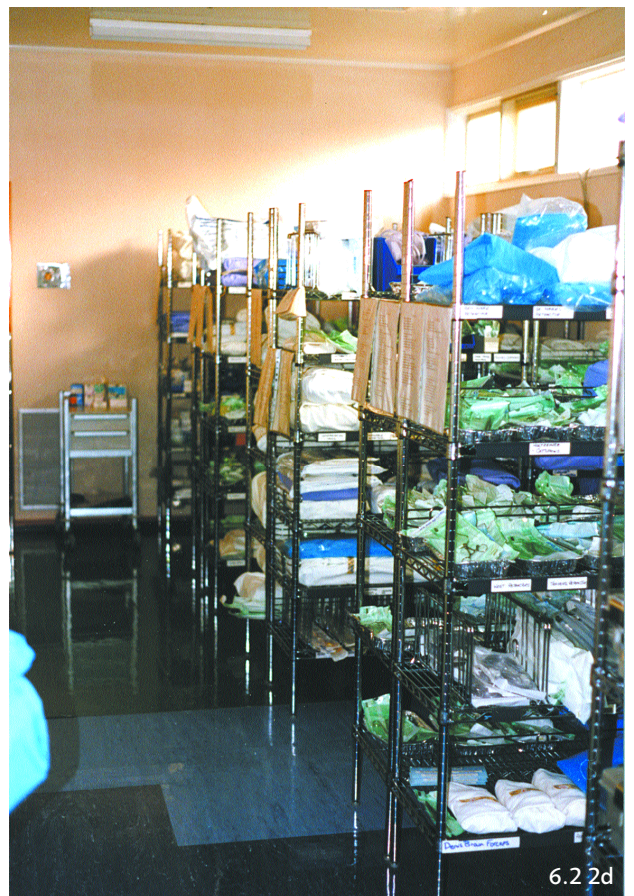
Unstable racking of theatre supplies (see Table 6.1)

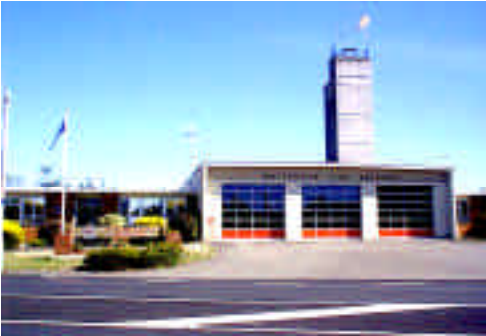
**MASTERTON FIRE STATION (SCREENED MARCH 2000)**

Building	Structural score	Building services and communication equipment	Furniture and contents and architectural elements
<p>Built 1967. Single storey. Appliance Bay is structural steel portals and reinforced concrete walls and floor slab. Offices and ancillary rooms are timber framed with brick and concrete masonry veneer on a reinforced concrete floor slab. Roofing is longrun corrugated iron. A detailed check of the Appliance Bay is recommended.</p> <p>Hose tower is connected to building. Torsional effects could cause damage in moderate to large earthquake. Structural advice is recommended (\$5000).</p>

<p>Appliance Bay 100 Offices/ Amenities 27</p>	<p>Generator - GM diesel capacity 50kW. Tank and batteries not secured. Provide restraint for fuel tank (\$400) and secure battery racks to walls (\$400).</p> <p>Fire extinguishers need quick release straps (\$50).</p> <p>Switch room should not be used for storage. HAZCHEM suits and compressed air cylinders should be removed.</p> <p>Hot water cylinder in laundry is not restrained. Provide brackets and strap cylinder to wall (\$50).</p> <p>Fix radio to top of cabinet with Velcro (\$20) and cabinet to wall with metal brackets (\$50).</p> <p>Fix radio, CPSU, and paging transmitter to top of cabinet with Velcro (\$20).</p> <p>Some rust on an aerial on the tower roof. Maintenance required to control rust (\$50).</p> <p>Provide slack in coax cables to allow movement (\$50).</p>	<p>Lockers in locker room need securing to wall (\$100).</p> <p>Attach computer, fax, and printer to desks with Velcro. Attach photocopier to floor and/or wall with brackets (\$50).</p> <p>Install catches on desk drawers (\$50).</p> <p>Heavy plaster tiles and suspended ceiling grid in lunchroom are inadequately restrained and tiles could fall during ground shaking. Adequately brace and secure grid to restrain tiles or provide light weight tiles (\$500).</p> <p>Lights in appliance bays and lunchroom are fixed only to the plaster ceilings and could fall with the tiles. Provide independent suspension for light fittings (\$500).</p>

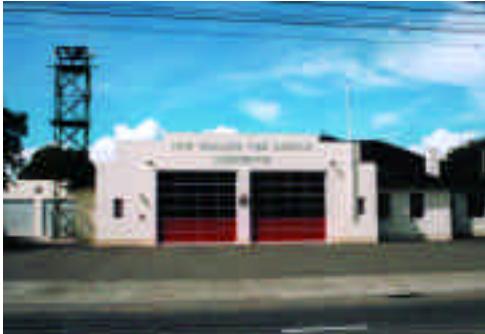
**CARTERTON FIRE STATION (SCREENED AUGUST 2002)**

Building	Structural score	Building services and communication equipment	Furniture and contents and architectural elements
<p>Built 1946. Single storey. Appliance bay has structural steel portals, RC floor slab and concrete masonry and timber framed walls, capable of housing two fire engines. Offices, stores, kitchen and social areas are timber framed with some concrete masonry walls, a stucco or plaster external finish and RC and timber floors.</p> <p>The hose tower is approximately 2.2 m<sup>2</sup> square and 12 m high and appears to be in good condition.</p>

<p>Appliance Bay 43 Offices/ Amenities 36</p>	<p>There is no emergency generator installation. Standby power for the alarms and control panel is provided by 12 V dry cell batteries</p> <p>Radio installation appears to be well secured.</p>	<p>The trolley should be fixed to the wall with quick release straps and the computer etc restrained on the trolley with industrial velcro</p>

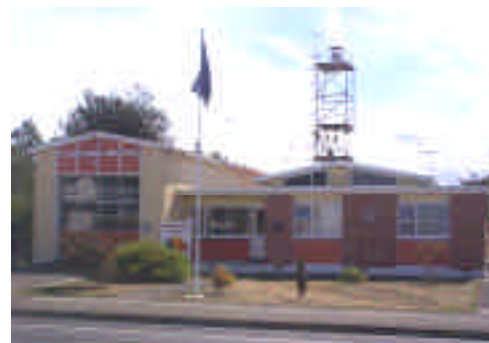
**GREYTOWN FIRE STATION (SCREENED JANUARY 2002)**

Building	Structural score	Building services and communication equipment	Furniture and contents and architectural elements
<p>Built 1962. Single storey. Appliance bay has structural steel portals with timber lining and metal cladding on the outside. Roof is corrugated iron.</p> <p>The hose tower is approximately 2.0 m square and 11.3 m high of galvanised steel angle. The steel is in good condition. The tower is secured to four concrete pads containing approximately 1 m<sup>3</sup> of concrete each. The tower carries a communications aerial at about 6 m.</p> <p>The social room is also used as the Greytown civil defence headquarters. It is 11 m x 6.2 m, has timber floors, gip on the walls and ceiling and aluminium windows. An annex, with a low angle roof and concrete slab floor extends out from the social room and is 8.4 m x 4.6 m.</p>	Appliance Bay 45 Office/ Amenities 36	A 7.5 kVA emergency generator in the appliance bay is capable of powering 5 emergency lights. The 20 litre fuel tank and battery needs securing to the ground.	<p>Secure computer, printer, copier and fax to desks with Velcro and secure desks to walls.</p> <p>Secure breathing cylinders to racks on wall or place on floor and secure.</p>

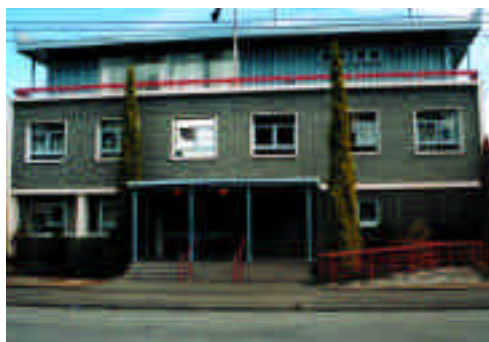
## MASTERTON POLICE STATION (SCREENED SEPTEMBER 2000)

Building	Structural score	Building services and communication equipment	Furniture and contents and architectural elements
<p>Built 1967/8. The station is three storeys and consists of a main block which is a three storey reinforced concrete shear wall structure. There is a single storey cell block also in reinforced concrete to the rear of the main block, and an adjacent timber framed single storey building to the east which is leased. A single storey garage block, also in reinforced concrete wall construction is located at the rear of the site. The cell block was upgraded in 1998. The main block has pad footings to the columns, strip footings to the walls, and piles to the timber ground floor. The cell block has strip footings to the walls and a reinforced concrete floor slab. The adjacent leased block is timber framed with a slab on-the-ground. All blocks have timber framed roofs and galvanised iron roofing with some structural steel support beams where necessary.</p>	<p>HQ 25 Cell Block 25</p>	<p>Emergency generator is an external stand-alone 48 kW unit. There is an underground, 5000 litre diesel tank shared with the hot water boiler. There is sufficient fuel to run for 24 hours on full load.</p> <p>External boiler room with diesel hot water boiler and large hot water cylinder 2.2 m high and 900 diameter. Restraint for HWC appears to be inadequate and should be checked out. The HD arrangement and restraint for the hot water boiler is not apparent and should be checked out.</p> <p>The 1351 HW cylinder in the cell block requires adequate restraint. The HW header tank appears to be adequately restrained. The AC unit on the wall of the typist's room needs fixing to the wall to provide restraint.</p> <p>Telephone components are well restrained but it is not possible to close the door which in an earthquake could swing and damage leads and impact components. It could also break and impact the Mainframe.</p> <p>Computer server towers (three boxes) are unrestrained and could move around the floor and impact other equipment. They should be penned in.</p> <p>Computer monitors should be restrained with industrial Velcro</p> <p>CLEAR box and modem shelves need proper fixings and the components restrained. Critical spares should not be stored on a shelf above the equipment where they can cause or suffer impact damage.</p> <p>The fixings of the radio aerial guys to the ribs of the large profile longrun galvanised iron roofing should be checked out.</p>	<p>The arms safe needs restraining and the cabinets fixed to the walls (\$200). Loose items stored on the top of cabinets should be removed.</p> <p>If kitchen is required in the response phase following an earthquake, kitchen equipment should be fixed or restrained and cupboards fitted with suitable door catches (\$100).</p> <p>If computer equipment in offices is essential for operations in the response phase following an earthquake, desks should be restrained and monitors fixed to desks with industrial Velcro (\$100).</p>

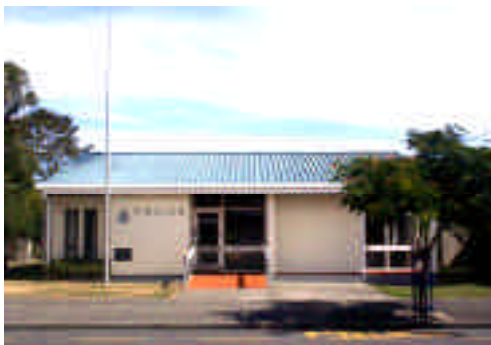
**CARTERTON POLICE STATION (SCREENED APRIL 2002)**

Building	Structural score	Building services and communication equipment	Furniture and contents and architectural elements
Built 1979. Single storey building of concrete block construction with a RC foundation. All walls are concrete block except for a small wooden 'kick out' section in the main office to allow for future extensions if required.	47	Fire extinguisher in the northeast office requires a quick release strap (\$20). The hot water cylinder in the cellblock needs to be better restrained to avoid damage in an earthquake (\$50). The radio in the main office needs securing to the desk (\$20).	The computers in both offices need to be fixed to the desks (\$40). The printer and the items on the high shelf above the desk in the main office should also be secured (\$30). The pigeonhole unit in the main office needs to be secured with brackets to prevent it from toppling over (\$20). Any unnecessary items should be removed from the main office and stored elsewhere as the efficient operation of this area will be important during an emergency. Fluorescent lights are hanging from hooks in the two offices. These need to be fixed securely to the beams or underlying structure, or with eye hooks to prevent them from becoming detached and falling during an earthquake.

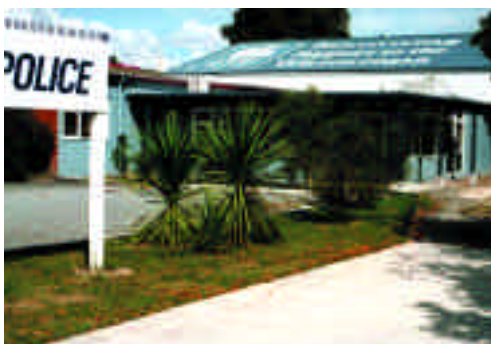
**GREYTOWN POLICE STATION (SCREENED APRIL 2002)**

Building	Structural score	Building services and communication equipment	Furniture and contents and architectural elements
Built 2000. Single storey timber frame construction with stucco cladding. Butinol roof.	22	Radio needs securing to desk (\$20).	Computer and printer in main office and pigeonhole unit in hallway need securing (\$100).

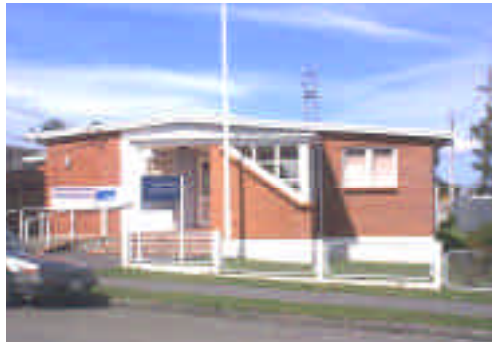
**FEATHERSTON POLICE STATION (SCREENED MARCH 2002)**

<b>Building</b>	<b>Structural score</b>	<b>Building services and communication equipment</b>	<b>Furniture and contents and architectural elements</b>
Built 1950's. Single storey brick veneer with strip footings and a low angle roof.	36	No emergency generator. All fire extinguishers need to be secured with quick release straps. The radio unit in the watchroom needs to be fixed to the desk to avoid movement and damage during an earthquake.	All computer equipment, including the printers need to be secured to the desks using either Velcro or screws (\$100). All items that are not necessary to operate the watchroom should be removed and stored elsewhere. Restraint needs to be provided for items stored on the bookshelves to prevent them from falling during an earthquake. The free standing storage in the two offices on the southeast side of the building needs to be fixed to the wall to prevent them from overturning in an earthquake. The filing cabinets also need some form of restraint in these rooms. The safe in the southeast office also needs securing (\$200). The video unit and cupboard underneath need securing to prevent the unit from toppling over (\$50).

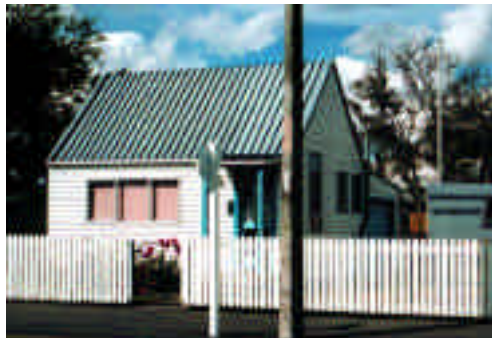
**MARTINBOROUGH POLICE STATION (SCREENED APRIL 2002)**

<b>Building</b>	<b>Structural score</b>	<b>Building services and communication equipment</b>	<b>Furniture and contents and architectural elements</b>
Built 1970's. The building is of single storey timber frame construction and is clad in weather boards. A steep angle roof covers the main office, entrance and toilet, while a low angle roof covers a storage area at the back of the building. There is a concrete slab foundation under the rear storage area.	22	Fire extinguishers need to be secured to the wall using quick release straps (\$40). The radio in the main office needs fixing to the desk with Velcro to prevent the unit from falling (\$20).	The safe and cabinets in the main office need securing to the wall (\$50). The tall lockers in the storage room and entranceway need fixing to the wall to prevent them from toppling over in an earthquake (\$50). Items on the high shelf above the computer desk need securing to prevent them from falling (\$50) Any unnecessary items should be removed from the main office and stored elsewhere.

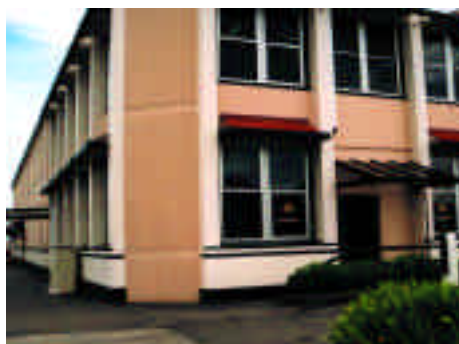
**MASTERTON DISTRICT COUNCIL CIVIL DEFENCE HEADQUARTERS (SCREENED SEPTEMBER 1999)**

Building	Structural score	Building services and communication equipment	Furniture and contents and architectural elements
<p>Built 1984. Two storey reinforced concrete structure with RC frames and deep exterior spandrels and tilt-up panels at 45 degrees to the southeast and northeast faces. The civil defence headquarters are seismically separated from the rest of the building. The headquarters would have been designed for the higher class loads for class 1 structures specified in NZS 4203 using an importance factor of 1.6. A capacity design approach would have been required by the code.</p> <p>The risk of loss of function of the headquarters is low, however, the WRC building can be used as an alternative site if necessary.</p>	50	<p>Standby generator has a fuel tank with a capacity of approximately 90 litres and a 12 hour running capacity. Underground 5000 litre diesel tank can be used to extend to at least 3 days running time. A hand held pump is available for refuelling. The standby generator needs additional restraint to prevent torsion (\$100).</p> <p>The individual batteries require partitions for restraint (\$100). The timber doors between the storage area and switchroom/standby generator should be replaced with fire rated doors (\$1500).</p> <p>Restraint needs to be provided to hot water lines, other water lines and drainage lines not restrained (\$1000).</p> <p>Additional restraint needs to be provided to PABX (\$1000).</p>	<p>Suspended ceiling elements need checking for fixing deficiencies (\$200). Light fittings need separate suspension system (\$500).</p> <p>The half height partitions to Treasury Offices are likely to be used during a civil defence emergency but are unstable. Fixings need to be provided to prevent overturning (\$500).</p> <p>The vulnerability of the computer installation from earthquake and water damage needs assessing. Restraint and protection should be provided if warranted (\$5000).</p> <p>Fire extinguishers need to be provided with quick release straps in the civil defence area and MDC offices (\$100).</p>

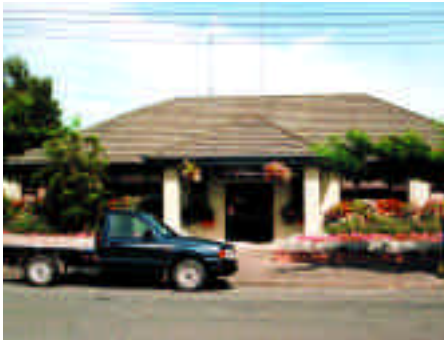
**CARTERTON DISTRICT COUNCIL CIVIL DEFENCE HEADQUARTERS (SCREENED OCTOBER 2002)**

<b>Building</b>	<b>Structural score</b>	<b>Building services and communication equipment</b>	<b>Furniture and contents and architectural elements</b>
Timber framed construction with exterior stucco finish. Council chamber added 1975. The addition was a structurally independent RC masonry building. Second extension carried out latter and there are no structural details. Third extension was Mayor's office in 1999? The lack of structural details for the second addition, the form of the extension with the short returns to the ends of the masonry walls, the resilience on dowels into the masonry walls of existing structures, and the removal of considerable lengths of external bracing walls to the original office building are matters of concern. A report from a structural engineer is recommended on the structural integrity of the building under seismic loads. In the interim, shifting the CD headquarters to the nearby timber framed Works Offices and yard or the Carterton Fire Station is recommended.	62

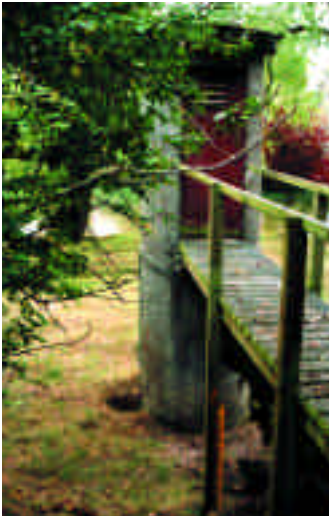
**WARDELL'S RIVER GAUGING SITE (SCREENED JANUARY 2001)**

<b>Building</b>	<b>Structural score</b>	<b>Building services and communication equipment</b>	<b>Furniture and contents and architectural elements</b>
Round (1-1.5 m diam), RC two story tower housing water level recorders and telemetry. Provides the WRC river information at the key sites on the Ruamahanga River. The building is founded in river gravels at least 2 m below ground level. Design of foundation should be checked by an engineer for its ability to resist earthquake shaking.	Not checked	Power supply is via mains power ducted through underground cable. Switchboard is adequately bolted to wall. Power supply converter box and radio unit should be restrained to the shelf using straps or Velcro, or a lip placed on the shelf (\$50).	The radio unit is located at top of access bank and is vulnerable too damage from bank erosion or landslide. Aerial could be moved further inland to reduce vulnerability (\$100).
