3.1 WATER SUPPLY

(1) Masterton

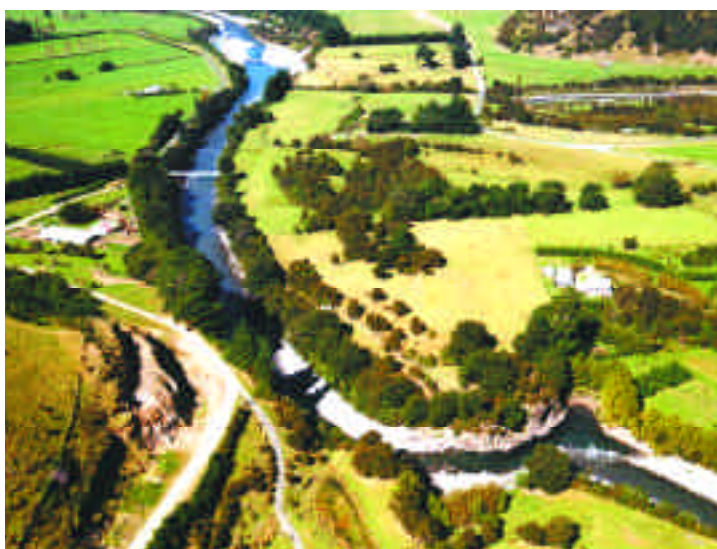
Figure 3.1. The Masterton water supply siphon intake is located in the pool in the foreground. Water is conveyed across the Waingawa River (Kaituna) in the middle distance.

This is seen as vulnerable to floods which bring down trees, which can damage the pipe intake. A seismic event could cause slipping of the rock face on which the pipeline is fixed, if the rock is fractured.

The intake pipe is that section of steel pipe below the rock face on the riverbank which extends into the river to extract water. The rock face is fissured and a rock slide could potentially damage the pipe. A geotechnical assessment of the rock face would determine the degree of risk. Mitigation measures could include reinforcing the rock face with mesh and rock anchor bolts. The other moderate risk is damage from the impact of large logs on the pipe and entangling of the pipe with debris. Mitigation measures should include a structural assessment of the strength of the pipe and, if necessary, determine any strengthening. An assessment of the rock face and pipe vulnerability is estimated to cost \$5,000.

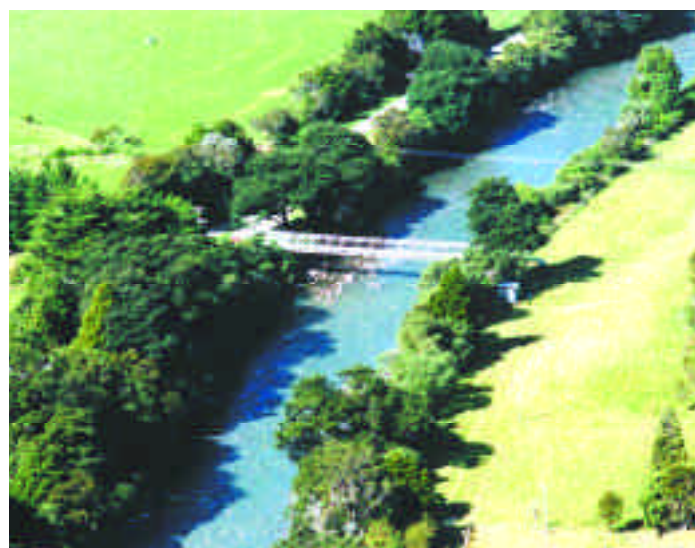
Figure 3.3. Pipe bridge conveying water over the Waingawa River to the Masterton treatment ponds.

This bridge over the Waingawa River supports the raw water pipeline which conveys water from the siphon to the raw water ponds. It is at a risk in the event of a flood because debris can build up behind an obstruction caused by floating trees. The hold-down mechanism of the bridge structure at the abutments

Damage to the pipe bridge is likely to be very significant for the whole structure, because considerable resources would be needed for repair or replacement.

There is a high risk of failure at the bridge abutments in a moderate to large seismic event. In very high floods, logs could catch on the structure and debris build-up could cause the bridge to fail. Mitigation measures should include a structural assessment and strengthening of the bridge. In the event that the bridge was damaged or destroyed, water could be pumped from the river into the main, at a point some 350 metres downstream of the bridge. The Council's portable low head high volume PTO driven pump would be used. The structural assessment and design modifications are estimated to cost \$5,000.

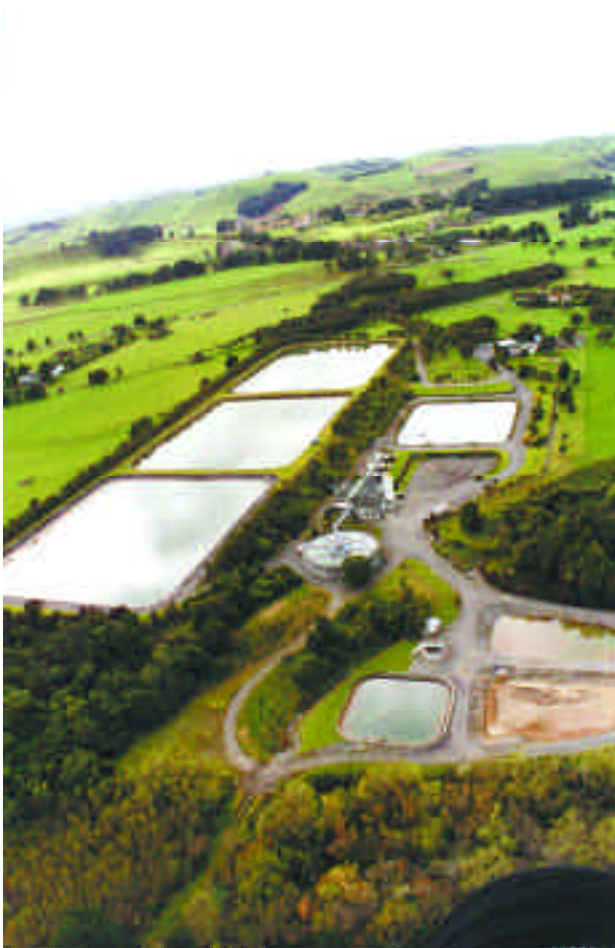
Figure 3.4. The Masterton water treatment plant at Upper Plain. The three water ponds are on the left of the picture and the clear water pond is in the foreground. The clarifier is in the middle of the picture and the filters and treatment plant building are above the clarifier.

These are three earth embankment ponds which have leaks in the embankments. The embankments are vulnerable in the event of earthquake or settlement. Failure of the embankment could be catastrophic, due to erosion and the forces of floodwater on surrounding land and structures. There is also a risk that, during a seismic event, water sloshing in the raw water ponds could damage surrounding structures. In the supply of raw water to the treatment plant the ponds could be bypassed. This would lower its ranking, but the consequences of a failure on the surrounding structures could be catastrophic. In order to bypass the ponds, the bypass valve would need to be opened, and the valve on the drawoff line from pond 1 would have to be closed.

The raw water ponds are vulnerable to a seismic event – either from sloshing overflow or pond rupture. Pond No 1 is concrete lined while the other two are unlined. Pond No 1 is the least vulnerable, and is expected to be the last to fail. The mitigation measure for the raw water ponds is to bypass the ponds.

The in-ground clear water pond is the most vulnerable structure in the event of a raw water pond failure. The other structures, such as filters, the treatment plant building and clarifier, are concrete and considered to be sufficiently robust to withstand sloshing overflow from the ponds. Mitigation measures include the planned replacement of the in-ground clear water pond with a reservoir. The reservoir will be sited clear of any impact from possible failure of the raw water pond.

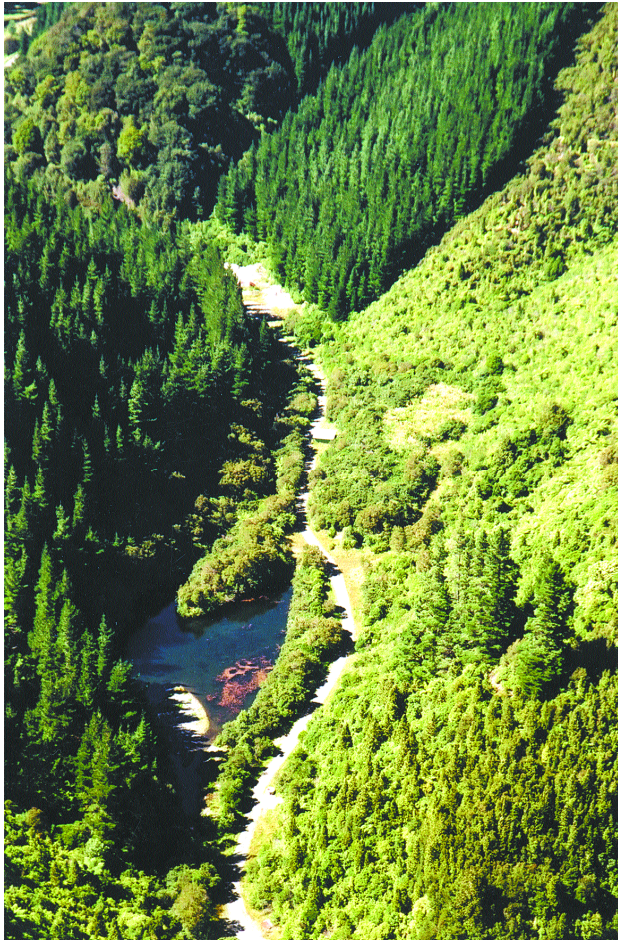
Figure 3.5 An impoundment dam on the Kaipatangata Stream forms one of the collection points for Carterton's water supply.

The dam could be ruptured by a major earthquake or filled with gravel by a landslide or major flood. Should the dam suffer a sudden failure, the resulting flash flood could wash out the access road to both the dam and a local lookout point. Such a flood could threaten the filtration plant and reservoir, which are adjacent to the bank of the Kaipatangata Stream, approximately 1.6 kilometres downstream of the dam crest.

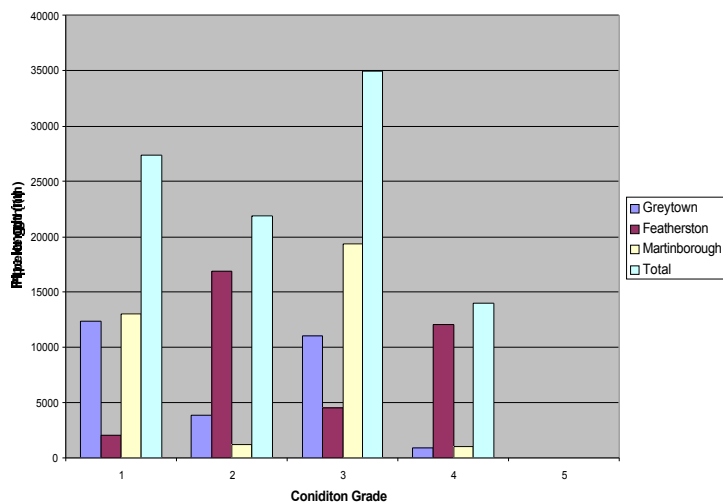
Figure 3.9. Summary of pipe condition for the water supplies of the south Wairarapa towns of Greytown, Featherston and Martinborough. (See Table 3.3. for an explanation of the grades)

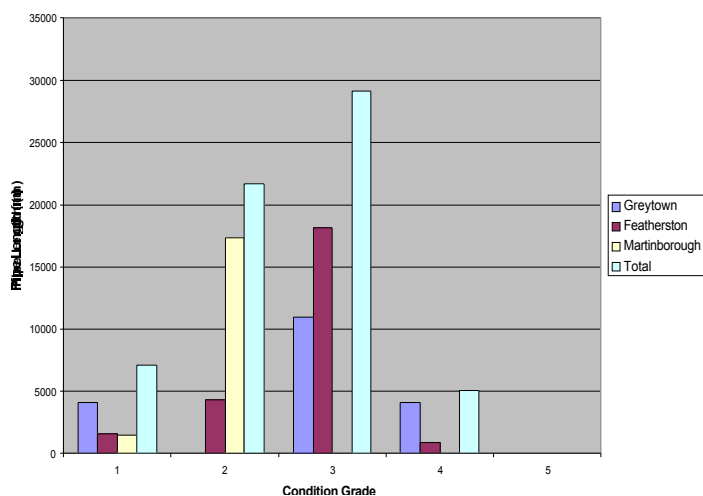
Figure 3.13. Summary of pipe condition for the sewer network of the south Wairarapa towns of Greytown, Featherston and Martinborough.

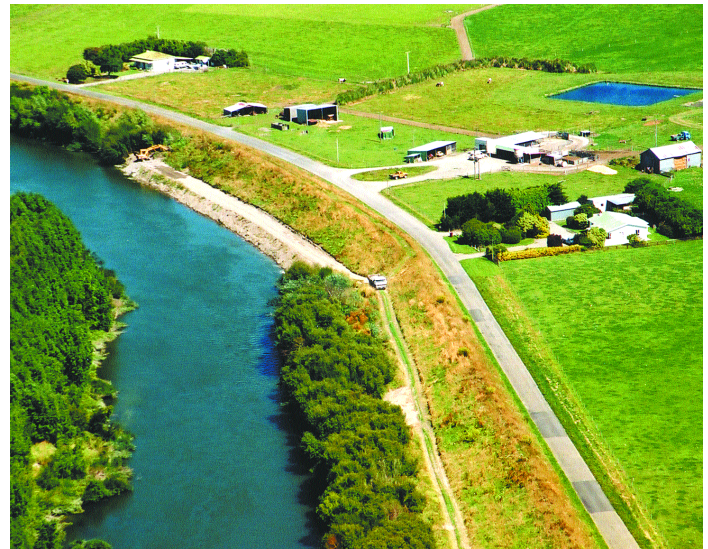
Figure 3.16. Part of the Ruamahanga River stopbank at Pukio, showing repairs in progress.
