Landslide response and monitoring – the New Zealand GeoNet experience

C.I. Massey, M, McSaveney & G. Dellow GNS Science with contributions from the GeoNet landslide team and others

The New Zealand GeoNet Project

An integrated geological hazards monitoring and data collection system, funded over 10 years by the New Zealand Earthquake Commission (EQC) and designed, built and operated by GNS Science

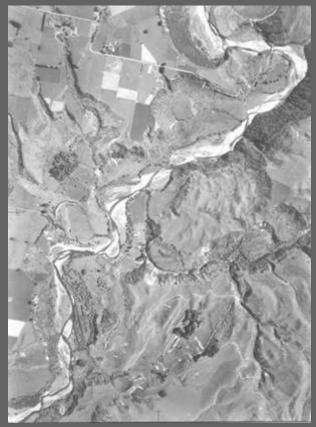
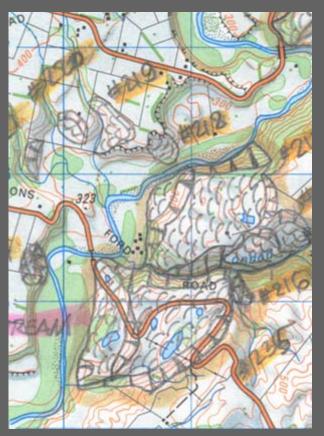
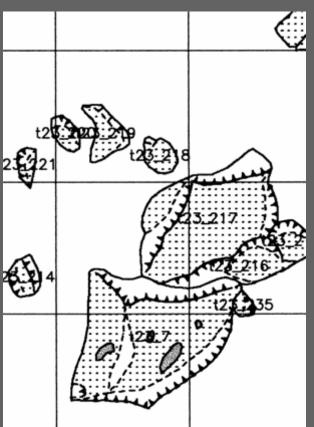
Landslide distributions

Inventory: mapped locations of landslides from aerial photographs, satellite images and field work

<u>Catalogue</u>: reported locations and time of occurrence (from 1996)

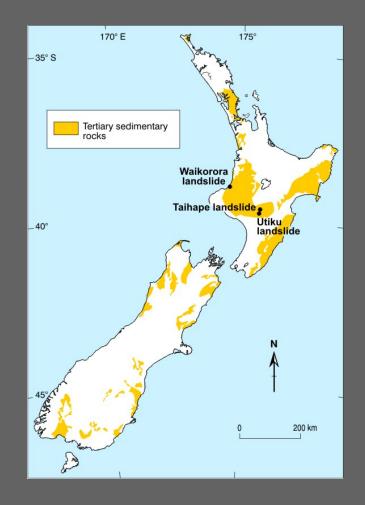
- Tertiary-age sedimentary rocks cover about 17% of New Zealand
- They host over 7000 large landslides (> 10,000 m²)
- Majority are slow-moving, deepseated, translational slides
- Taihape and Utiku landslides are two examples

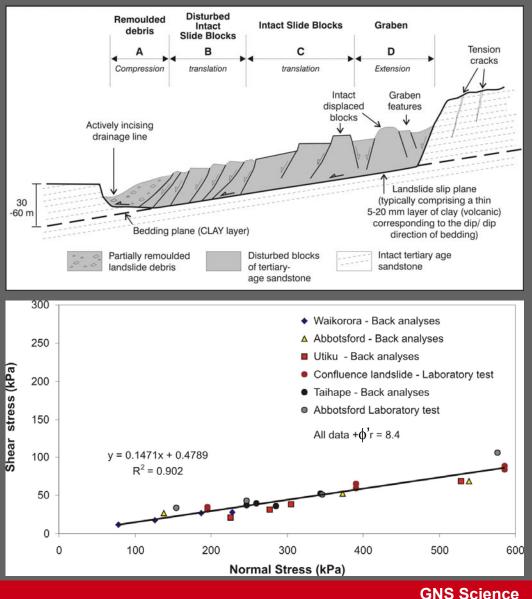
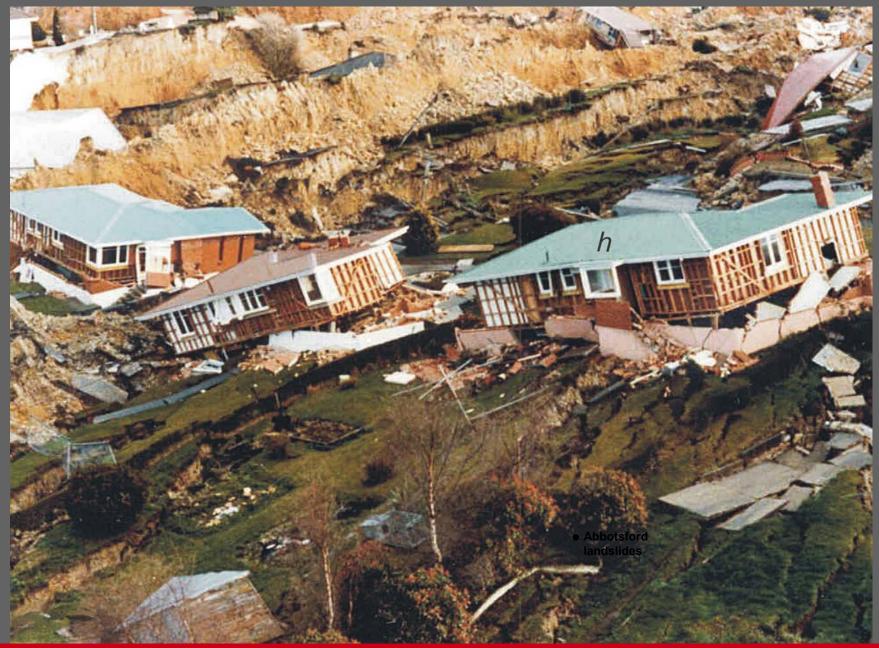
• Movement along thin clay seams, parallel or sub-parallel to bedding

Friction angle of clay seams < 10°

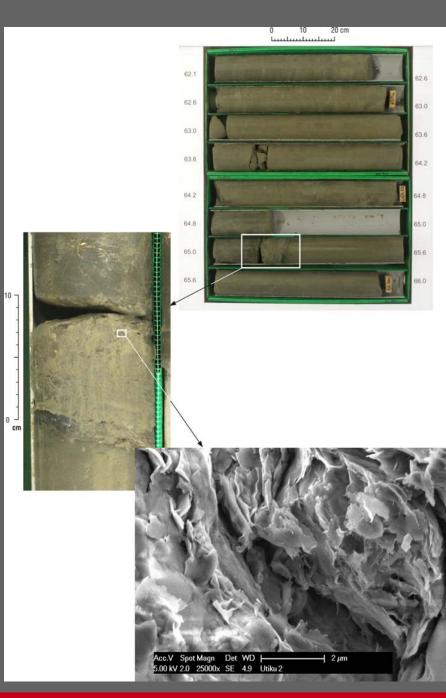
- Clays are smectites of the montmorillonite group
- Believed to originate from volcanic ash

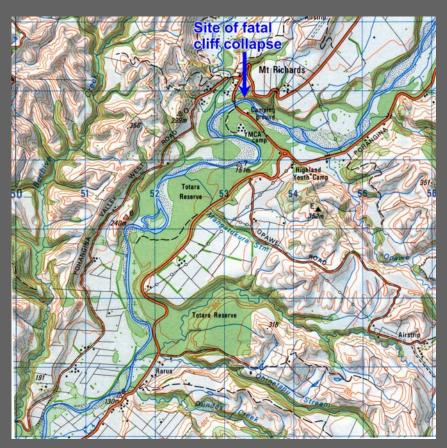
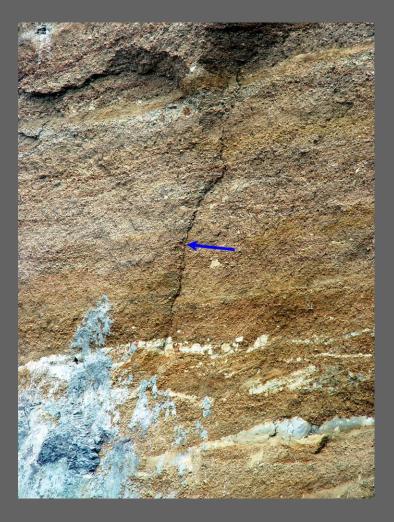
Death or serious injury – Totara Reserve

- River scour at foot of cliff on outside meander bend
- Site is popular for camping, picnics and swimming
- Cliff collapse is recognised but rare
- Eventually, collapse and swimmers will coincide

Thin 500 m³ slab peeled off

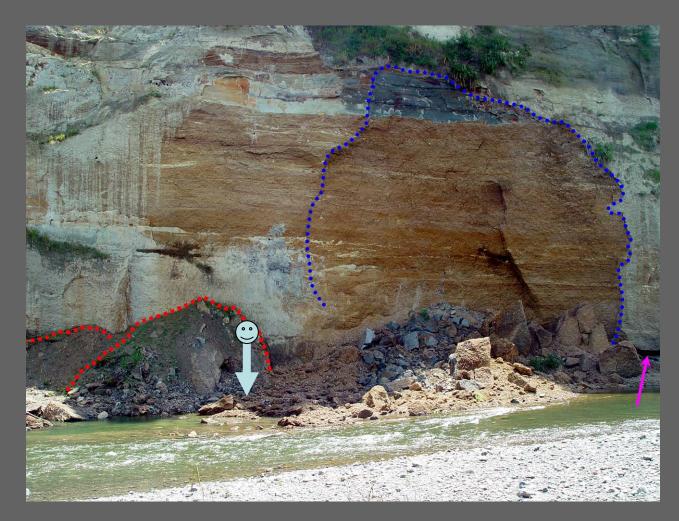
Death or serious injury – Totara Reserve

- 3 children killed while swimming
- 1 survivor
- 24-hrs earlier
 70 people
 were here

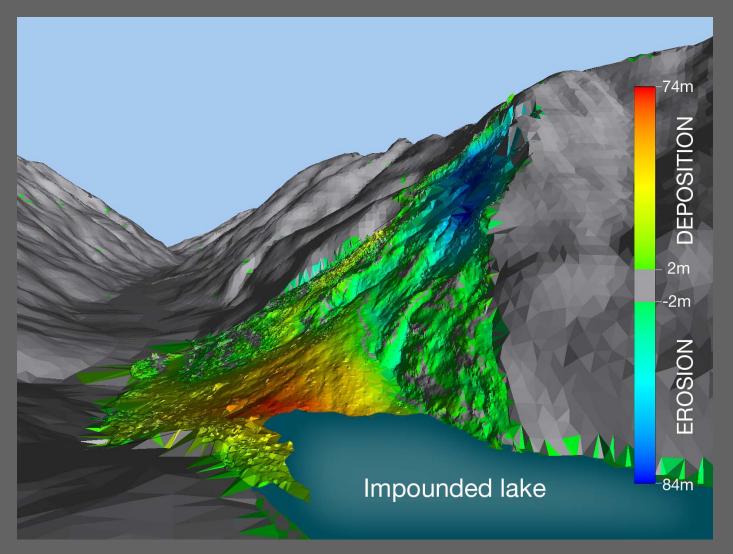
Young River landslide dam

Change model derived from TLS survey

Location	Young River Landslide, North Branch Young River (Mount Aspiring National Park), New Zealand, which is a tributary of the Makarora River.
Initiation Date/time	04:40 on 29 August 2007
Trigger	No obvious trigger (no rainfall three weeks prior to
	initiation and no earthquakes recorded)
Landslide Volume	11 Million m ³
Velocity	100 km/hour (minimum)
Runout distance	1.8 km
Impounded Lake Volume	23 Million m ³
Dam height (at outflow channel)	70 m

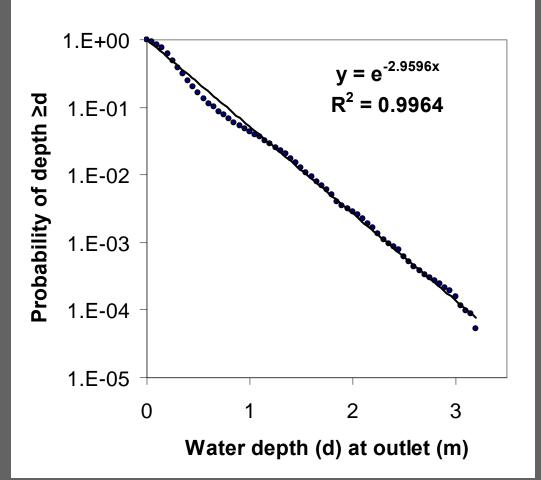
Young River – outlet level

- 3 years of monitoring
- 3 down cutting events recorded
- Total lowering ~ 0.7 m
- Lowering occurs at water depths > 2.1 m (max. depth recorded 3.4 m)

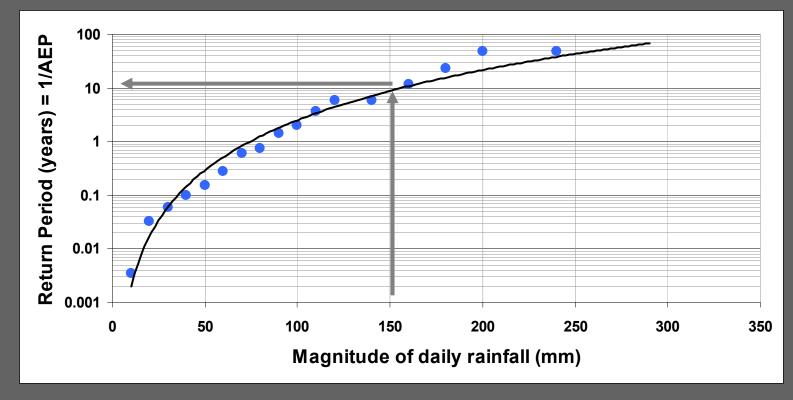
Young River – How has the dam been tested??

• Rainfall - Max. at dam equivalent to 1:10 year event

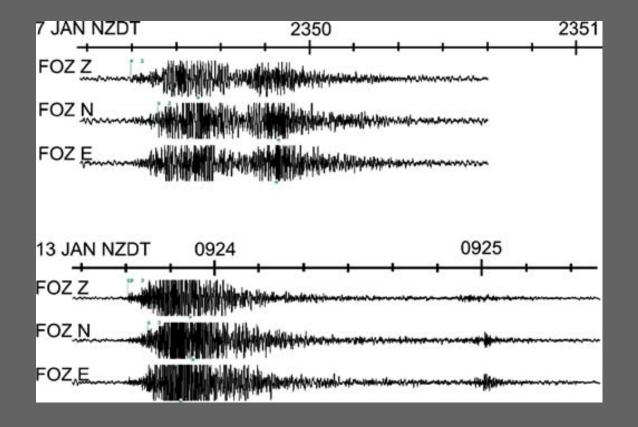
Recorded on seismic network in January 2008

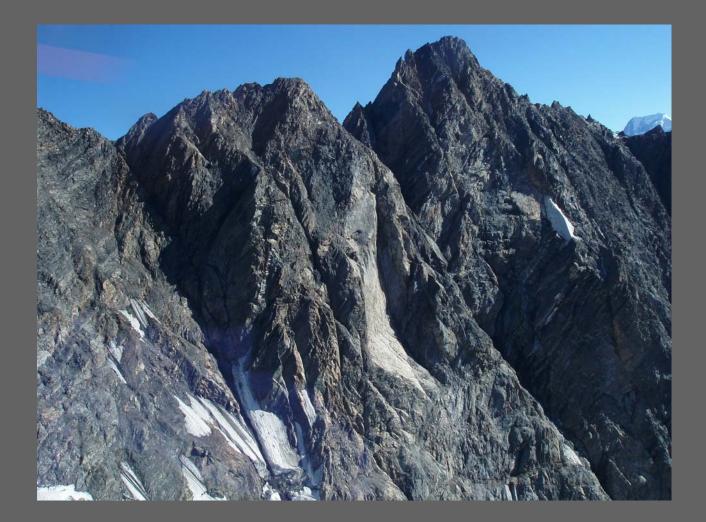
Looks to be defect-controlled, but it isn't
