An update from the lab... Volcanic Ash Testing Lab (VAT Lab)

National Lifelines Forum – 23 September 2010

Tom Wilson, John Wardman, Carol Steward, David Johnston, Pat Bodger, et al.

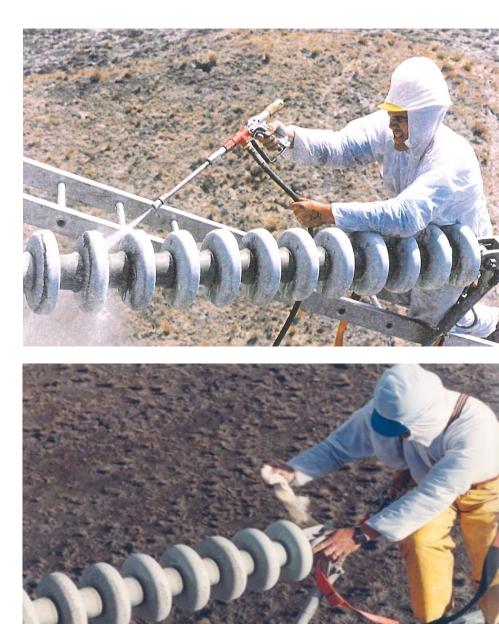
Post Eruption

27th September, 1995

4 Crews of 4 men dispatched18 towers

Cleaning methods:

•Water Blasting (1500 psi) •Fire Hosing

•Dry wiping (mutton cloth)

•Knapsack sprayer & cloth

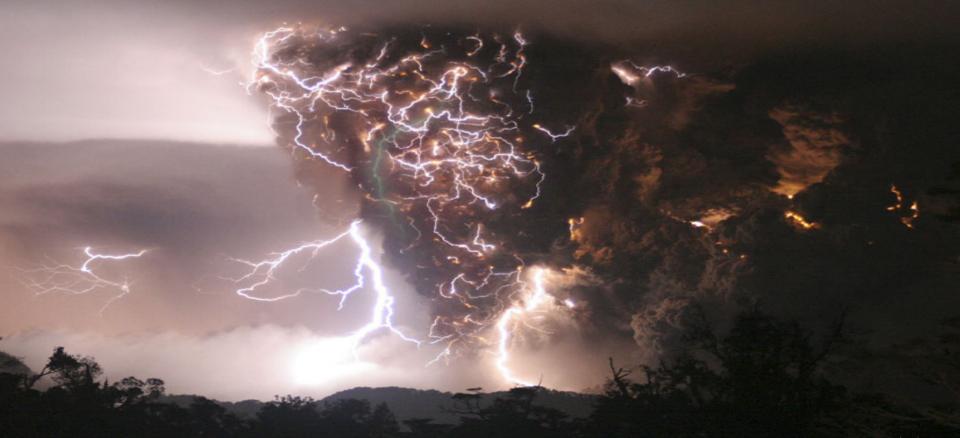
Quantifying the Vulnerability of High Voltage Transmission Systems to Volcanic Ashfall Hazards

Electrical Resistance Testing

- Opportunity to implement a new practice
 - International interest
- Measure resistance of various ash types in 'electrode dock'
- Cleaning when ESDD ≥0.03mg/cm2
- Nellis & Hendrix 1981: Ash 3-6mm thick=ESDD 0.3-0.6mg/cm2
- Investigate controlling variables
- Compare & Identify suitable proxy

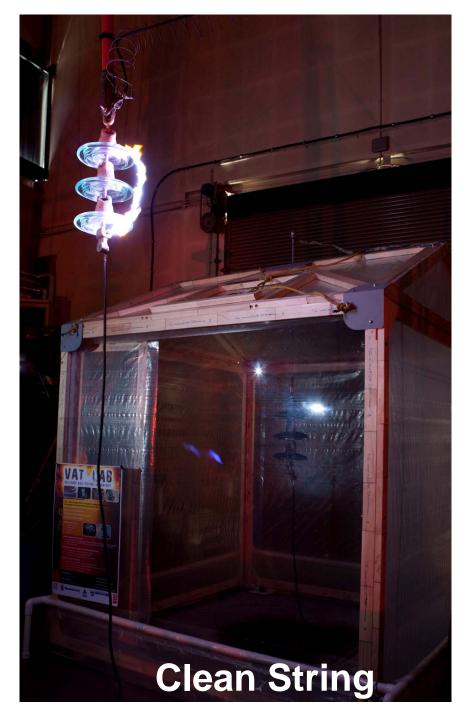
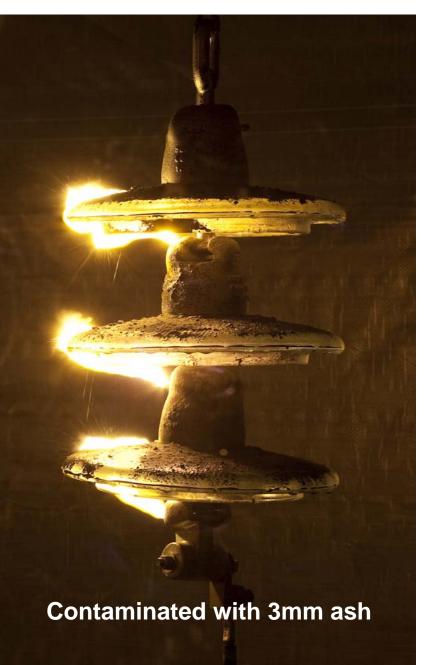
Contamination Testing

- Power-frequency testing of high voltage insulators contaminated with volcanic ash
 - 350 kW power capability, 50 Hz
- Test insulators of varying ratings, design and composition
 - Porcelain, glass, composite polymer
- Control and quantify major variables leading to flashover
 - i.e. moisture type/rate, ash volume, grain size, etc.
- Leakage current and geotechnical analysis of adherence properties

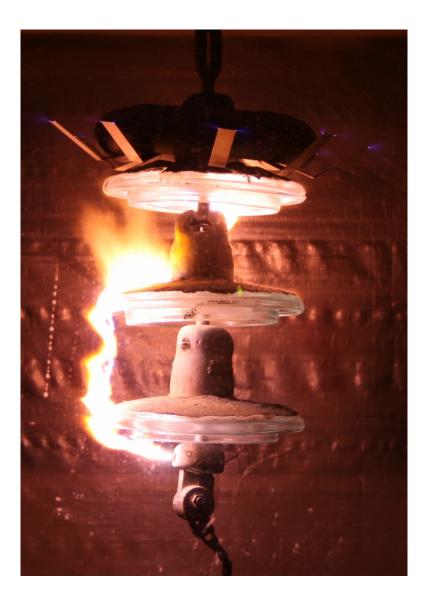
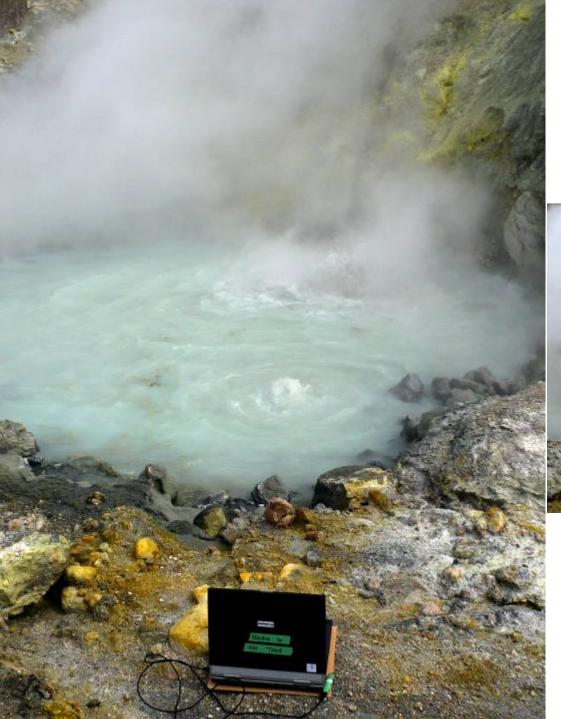
Insulator Design

- Inform design criteria for volcano proximal or heavily polluted areas
- Self cleaning options?
 - Corona wind
 - TiO₂ (titanium dioxide) film
 (Yuzhen *et al.*, 2009)
 - Effectiveness of RTV greases?

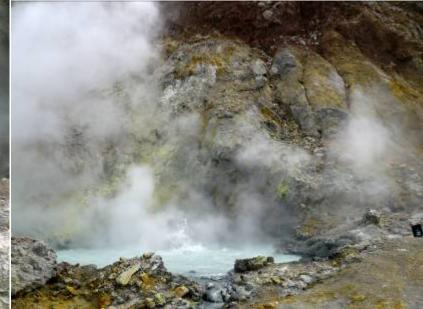
- All laptops kept working and are still working – tested on a 1 month cycle...
- Laptop 2 showed the most effects
 - Copper of heat sink and copper tape were discoloured
 - Some rust on internal stainless steel
 - Screen and keyboard were covered in H₂SO₄ residue
- Other laptops showed little effect
- USB cable plugs corroded
- Ash testing is next....

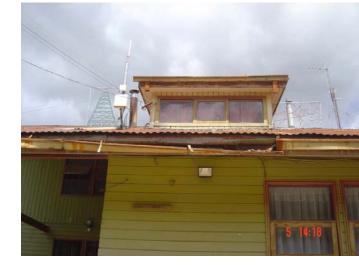
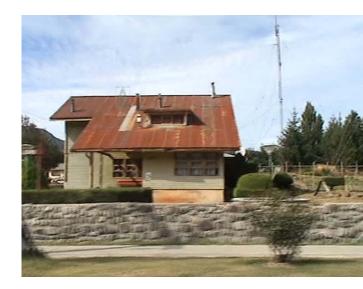
Ash fall impacts to roofing

Futaleufu, Chile received 200mm of ashfall followed by snowfall 10 days later.

•No structural collapse occurred

•>25% of the building stock exhibited heavy rust damage>20% suffered gutter collapse or damage.
