Cyclone Gabrielle Recovery Report | 29 June 2023

Reporting Period: 23/06/23 – 29/06/23
Weekly update on Cyclone Gabrielle recovery activity

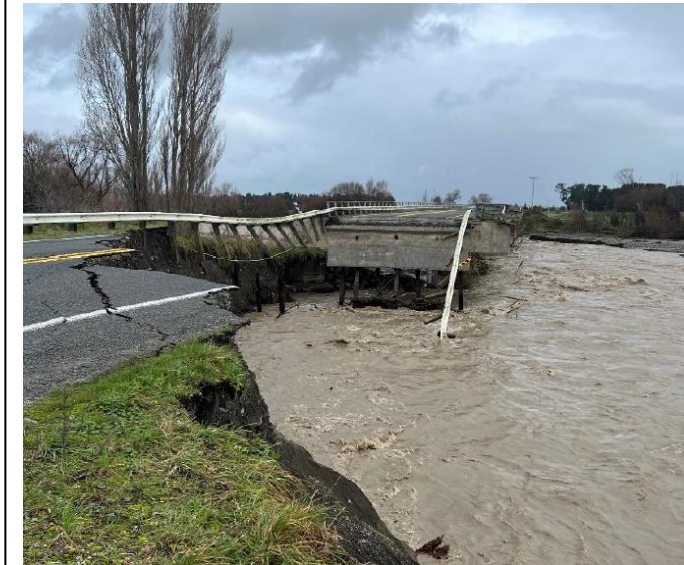
26 June 2023: SH50 at Waipawa bridge

- Is now closed between Tikokino and Ongaonga due to a bridge abutment being washed out during the recent weather event. The expected timeframe of repair is 3-4 weeks, re-opening by the end of July.
