3.1 WATER SUPPLY

(1) Masterton

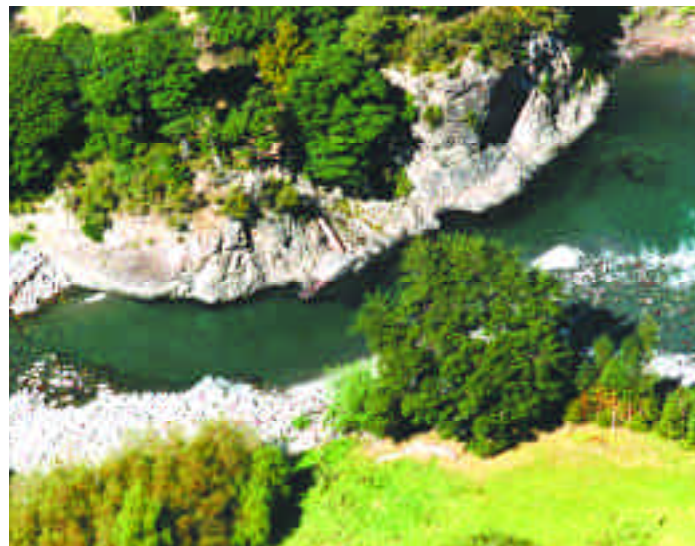
Figure 3.2. Waingawa River at Kaituna and the siphon intake for the Masterton water supply.

This is seen as vulnerable to floods which bring down trees, which can damage the pipe intake. A seismic event could cause slipping of the rock face on which the pipeline is fixed, if the rock is fractured.

The intake pipe would be difficult to replace or repair because of the limited access and difficult nature of the site.

The intake pipe is that section of steel pipe below the rock face on the riverbank which extends into the river to extract water. The rock face is fissured and a rock slide could potentially damage the pipe. A geotechnical assessment of the rock face would determine the degree of risk. Mitigation measures could include reinforcing the rock face with mesh and rock anchor bolts. The other moderate risk is damage from the impact of large logs on the pipe and entangling of the pipe with debris. Mitigation measures should include a structural assessment of the strength of the pipe and, if necessary, determine any strengthening. An assessment of the rock face and pipe vulnerability is estimated to cost \$5,000.

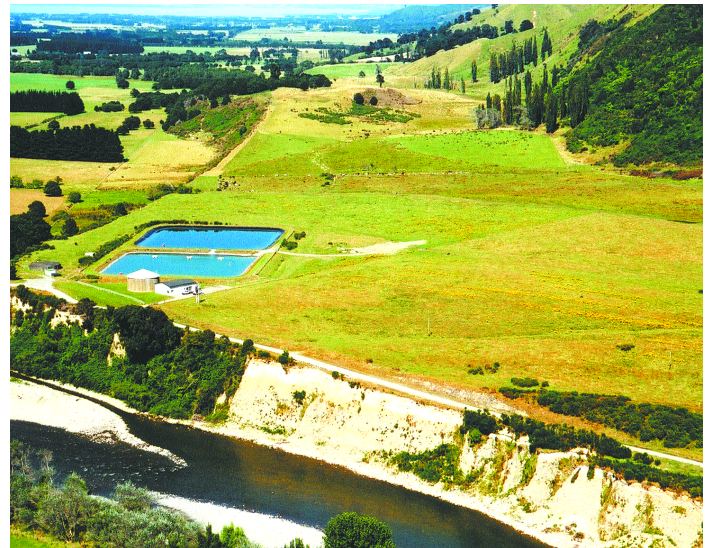
Figure 3.6 Waiohine River intake to Moroa water race and Greytown/Featherston water supply. The filtration plant and storage ponds are sited to the west of the Wairarapa Fault.

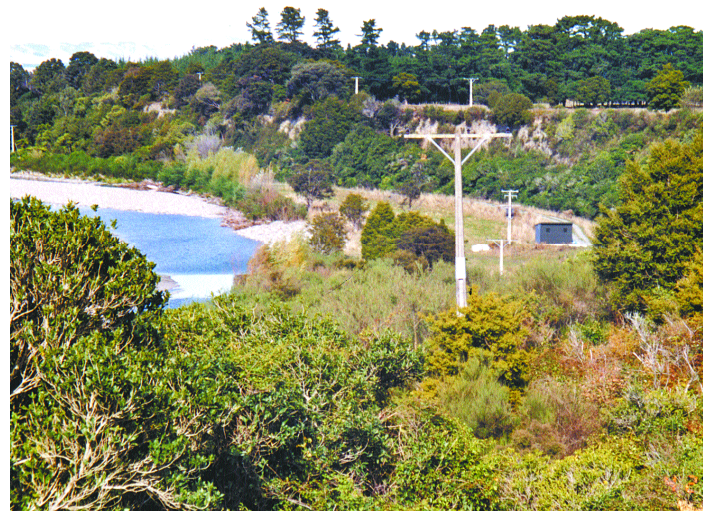
Figure 3.7. Waiohine River intake pumps for the Greytown/Featherston water supply.

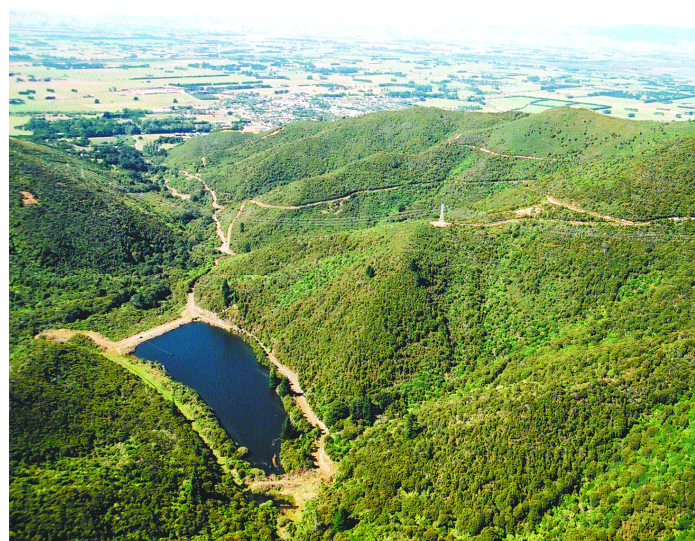
Figure 3.8. Boar Bush Gully dam supplying Featherston water.

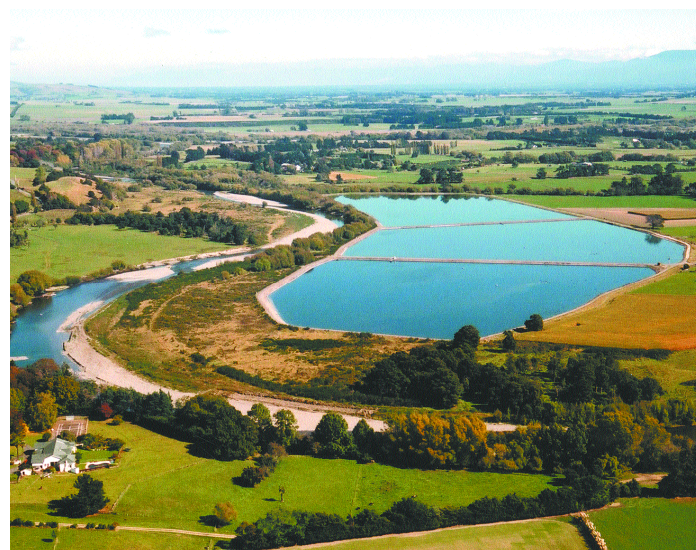
Figure 3.10. Masterton sewage treatment ponds at Homebush. The two primary ponds are in the foreground and the secondary pond and discharge are in the background.

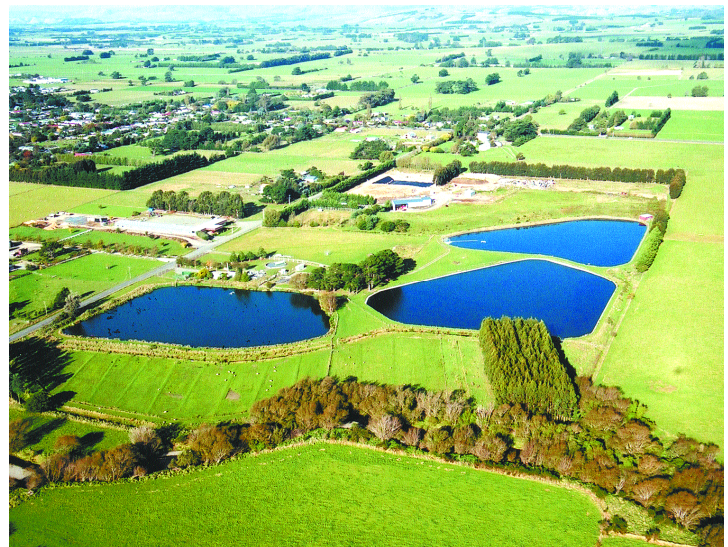
Figure 3.11. Carterton sewage treatment plant at Dalefield. The plant buildings in the centre of the photo are surrounded by the three treatment ponds. The Mangaterere Stream is in the foreground.

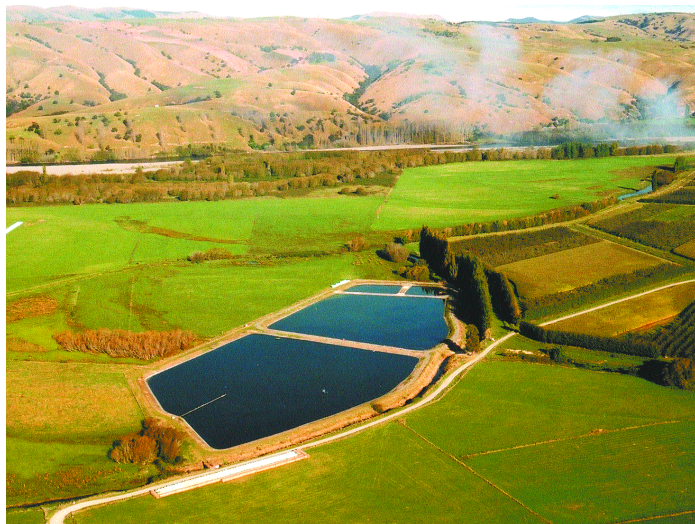
Figure 3.12. Greytown sewage treatment ponds.

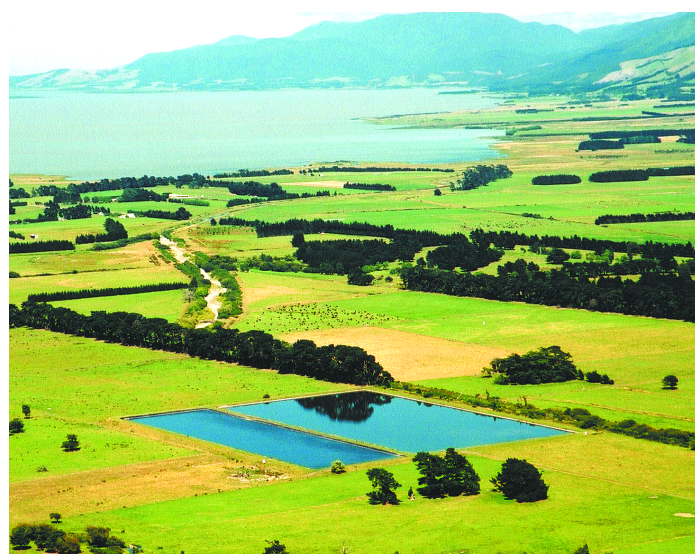
Figure 3.14. Featherston sewage treatment ponds.

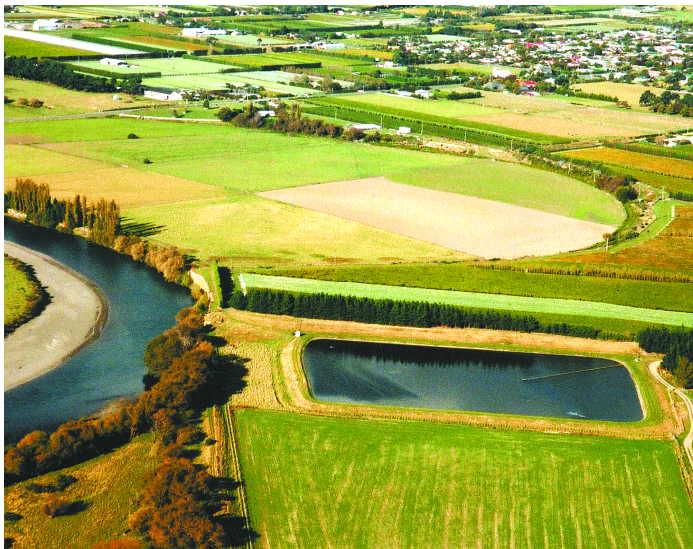
Figure 3.15. Martinborough sewage treatment pond and the Ruamahanga River.

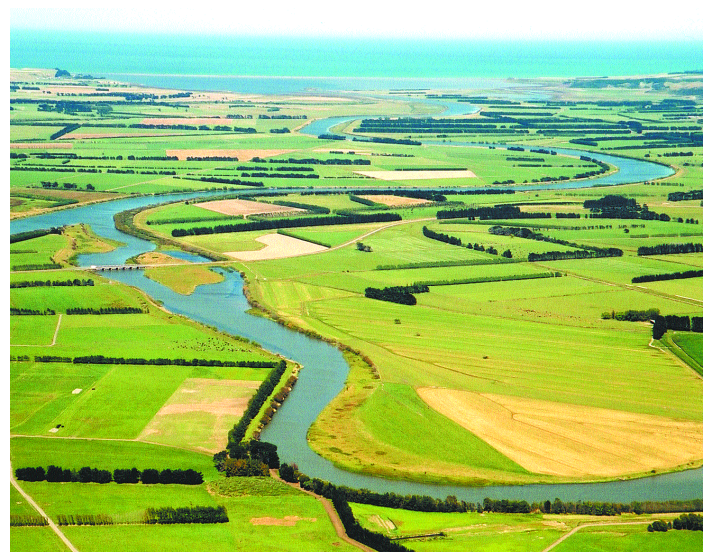
Figure 3.17. Lower reaches of the Ruamahanga River outlet from Lake Wairarapa. The Blundell Barrage combined flood protection structure and road bridge is located before the junction with the Ruamahanga River. All the flat land in the picture depends on stopbank protection and land drainage pumps.

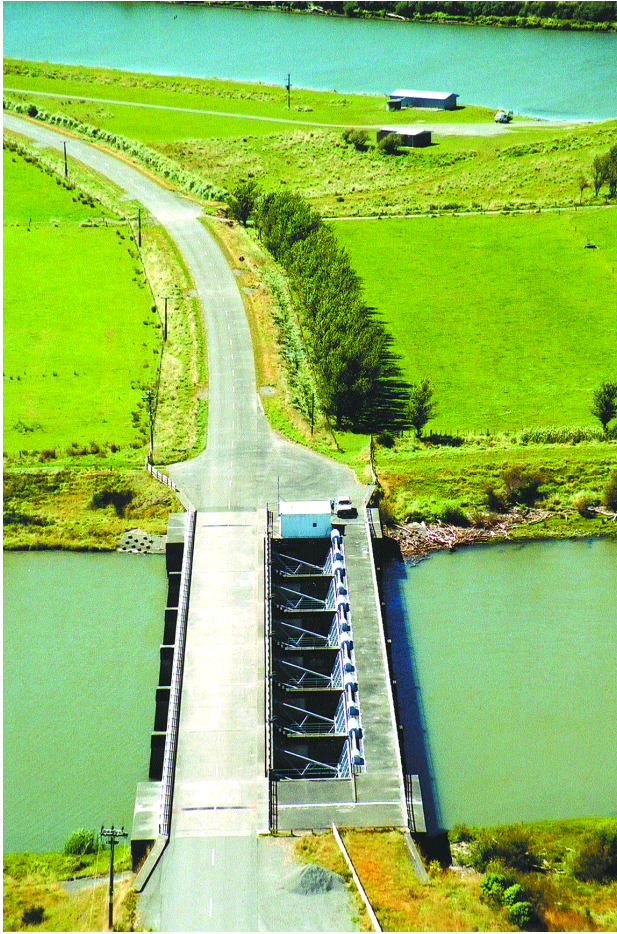
Figure 3.18. The Blundell Barrage is a combined flood control structure and road bridge. The Ruamahanga diversion and Boat Club are visible in the top of the picture. The radial steel gates control water levels and flood storage in the Lower Wairarapa Valley.

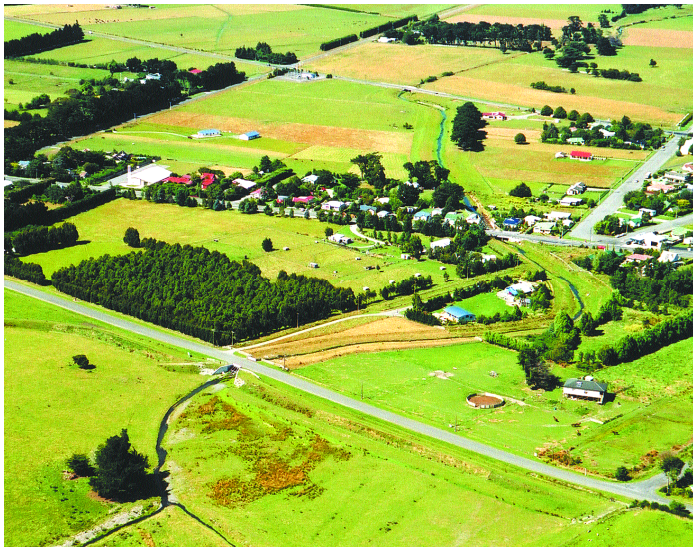
Figure 3.19. Flood detention dam and stopbanks for Donalds Creek, Featherston. State Highway 2 is in the centre of the picture and State Highway 53 is in the top of the picture.

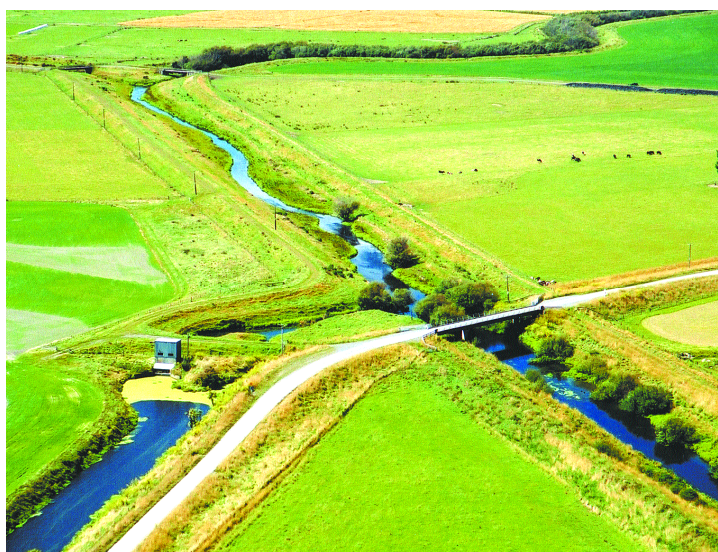
Figure 3.20. Pouawha pump station in the Lower Wairarapa Valley. Twin electric pumps lift the water from the low-lying former Pouawha lagoon.

All pumps have cast iron casings. The pumps and motors are usually supported at their lower ends by structural steel grillages (in one case at mid-height), and a bolted flange connection to a steel puddle flange cast into the cell diaphragm wall. There is no restraint at floor level.
