4 Transportation

4.1 INTRODUCTION

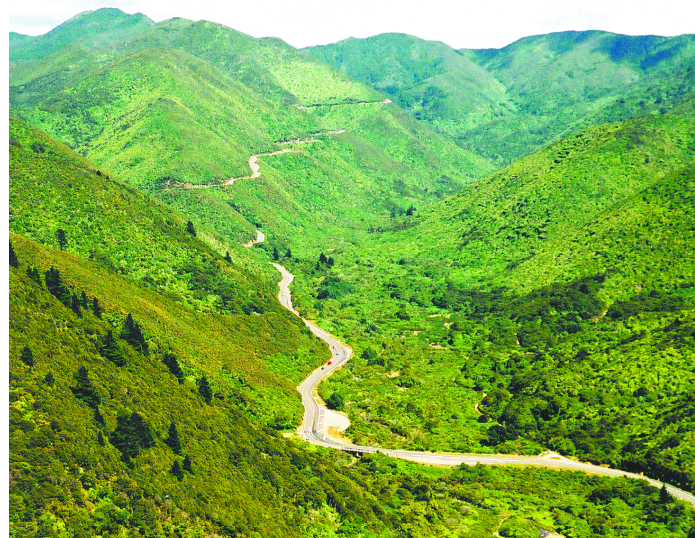
Figure 4.1. SH2 Rimutaka Hill road looking towards the summit from the Abbots Creek twin bridges.

The Rimutaka Hill road's vulnerability from earthquake would depend on the stability of the slopes above and below it. Following an earthquake there could be slips onto the road and dropouts and slumping where the road is built on scree material. Failure of walls constructed to support the road might also occur (See Wellington Regional Council

It would probably take a few days to assess the damage. Several weeks might be needed to restore a one lane roadway across the hill – depending on the degree of dropout damage, the priority for restoration, and availability of resources.

Bridges 1, 2 and 4 crossing Abbots Creek have a low likelihood of damage except for Rimutaka No. 4 southbound, which is duplicated. They are, however, close to the Wairarapa Fault.

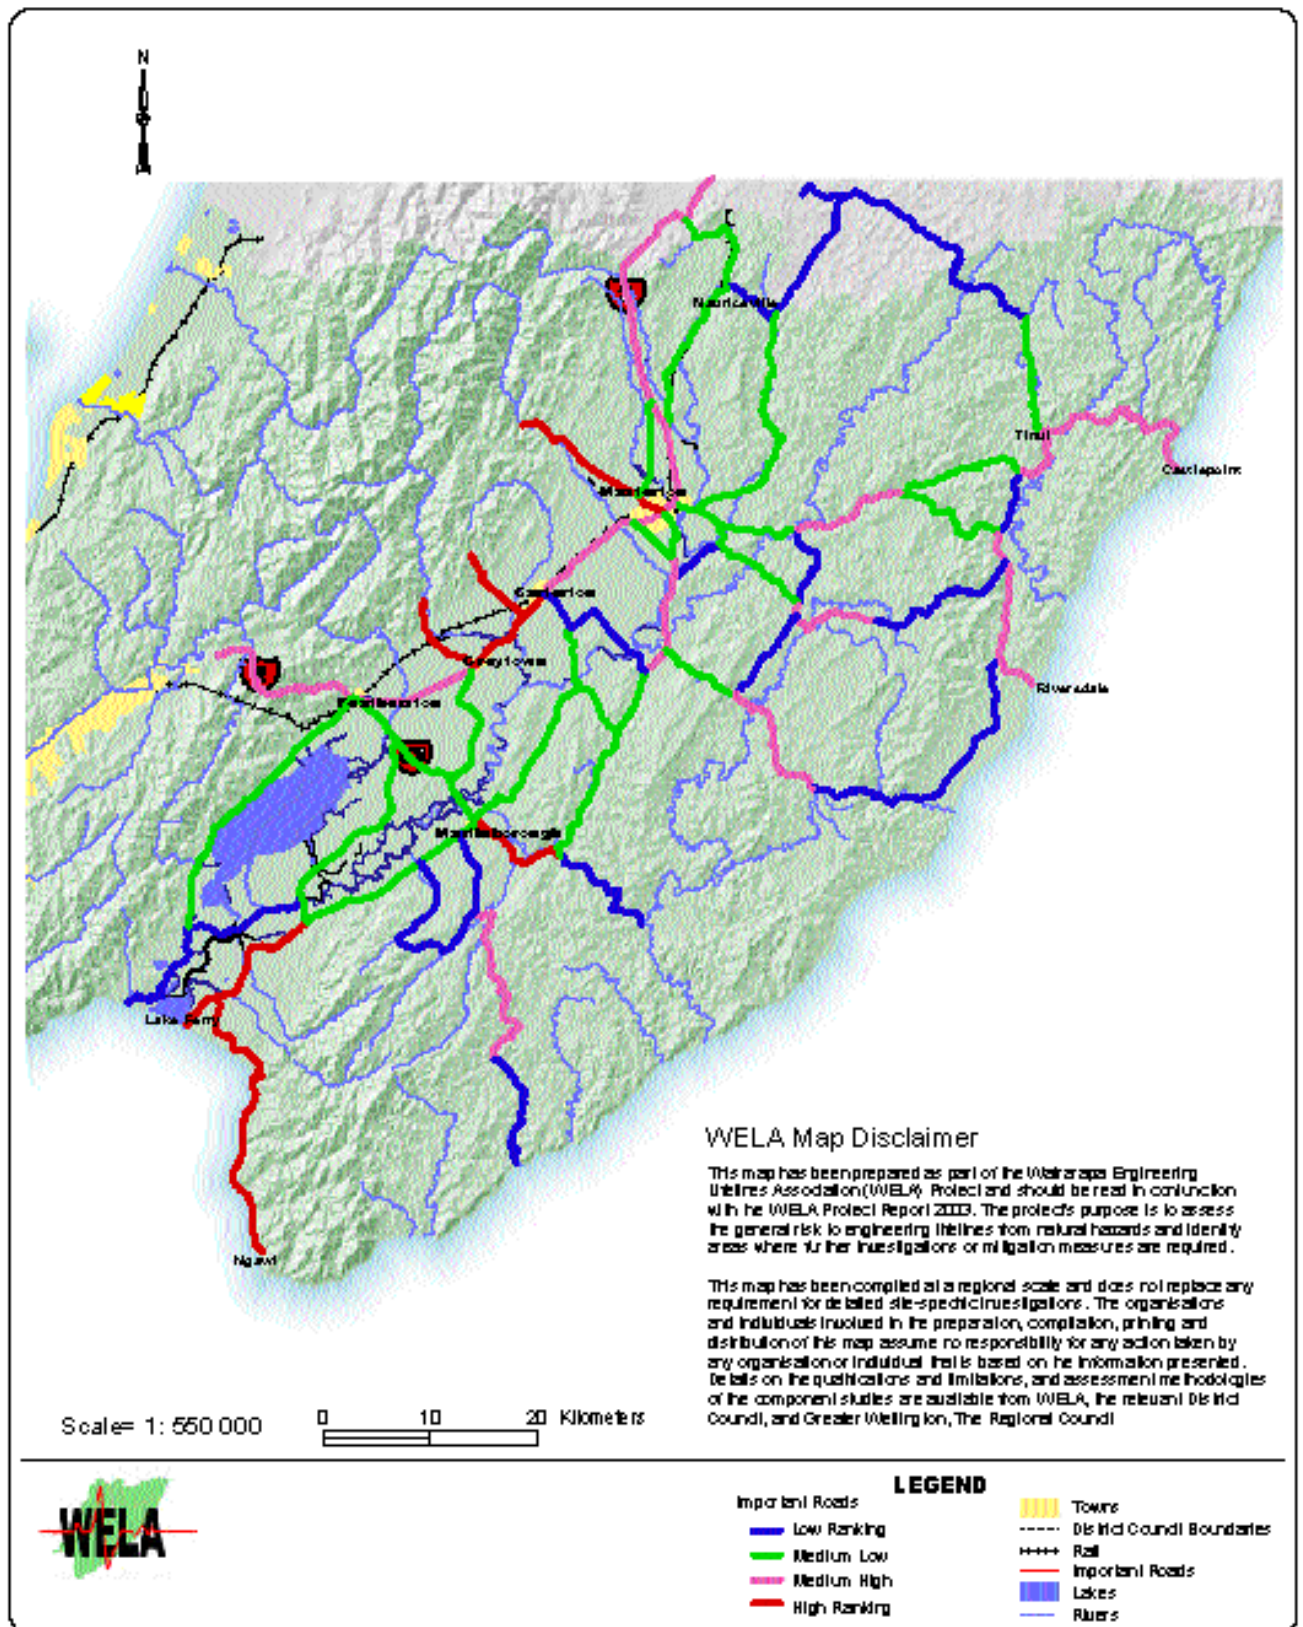
Important Roads

Figure 4.4 shows the important routes which have been selected. These routes have been ranked in accordance with WELA Note 5. Road sections and bridge components have been rated highly if they are essential to the network and if large parts of the network would be disrupted if the components failed or were damaged. The importance factor has been reduced if the component had alternatives, could be bypassed, caused only localised disruption or was low in the network hierarchy. The total length of important route for the three districts is presented in Table 4.4.

Figure 4.4. Important routes and their rankings (1-4) for the three Wairarapa districts.
