2 Natural hazards in the Wairarapa

2.1 INTRODUCTION

2.2 EARTHQUAKE HAZARDS

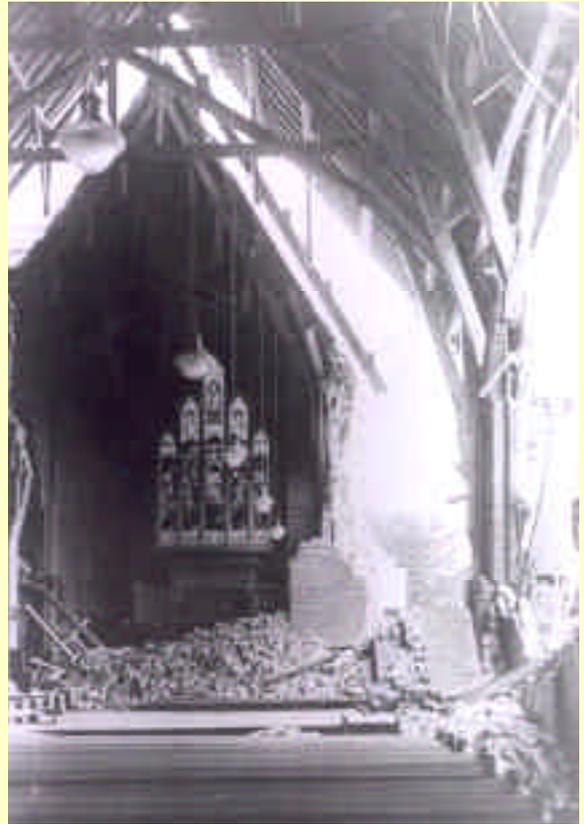
Figure 2.6. 1942 Earthquake damage to St Matthew's church in Masterton. Unable to be repaired, the church was later demolished by the Army. Source: Alexander Turnbull Library.

There was extensive damage in Masterton. Houses swayed, chimneys fell, electricity was cut, and broken water mains flooded houses. Up to £500,000 damage occurred. Fortunately no one was injured in the town (Rogers, 1996). St. Matthew's Anglican Church looked like a bomb had hit it. Its eastern wall collapsed, the organ was destroyed and many windows shattered (Figure 2.6). The damage was so bad the Army had to demolish the church with explosives. Several stores, including Bullick & Blackmore in Queen St, lost their entire frontages (Figure 2.7). In one case the upstairs living quarters were completely exposed. A 40,000 gallon water tank toppled through the Farmers Co-operative building, causing much damage (Rogers, 1996).

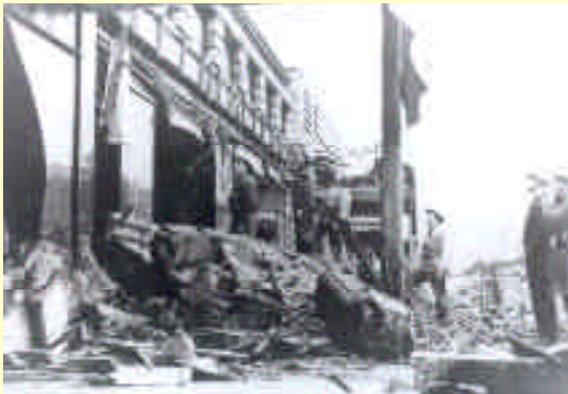
Figure 2.7. Many stores, including Bullick and Blackmore in Masterton (pictured here) were severely damaged by the 1942 Masterton earthquake. Source: Alexander Turnbull Library.

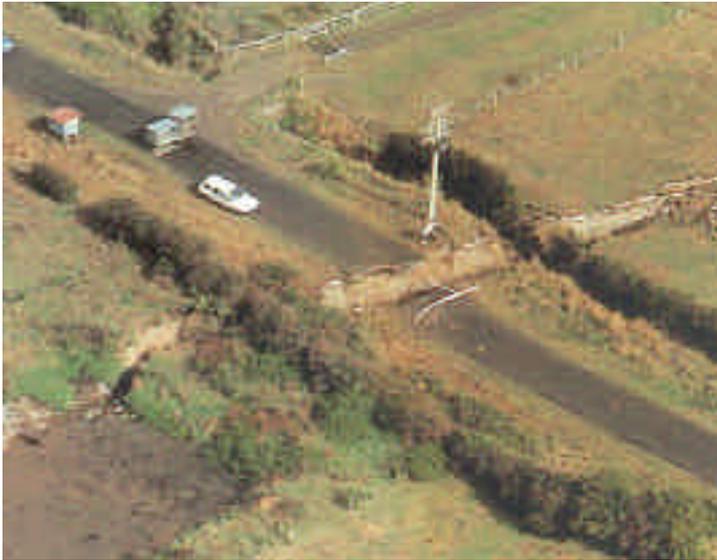
Figure 2.11. Surface rupture of the Edgcombe Fault from the 1987 Edgcombe Earthquake. Note the relatively confined linear area of disturbance. Source: Aitken (1999).

Fault displacement is the displacement, horizontally and/or vertically of the sides of the fault fracture or fracture zone, relative to one and other. *Ground settlement* is the change in level, positive or negative, of the ground surface due to seismic induced compaction, folding, or tilting of the Earth's surface (Figure 2.11).

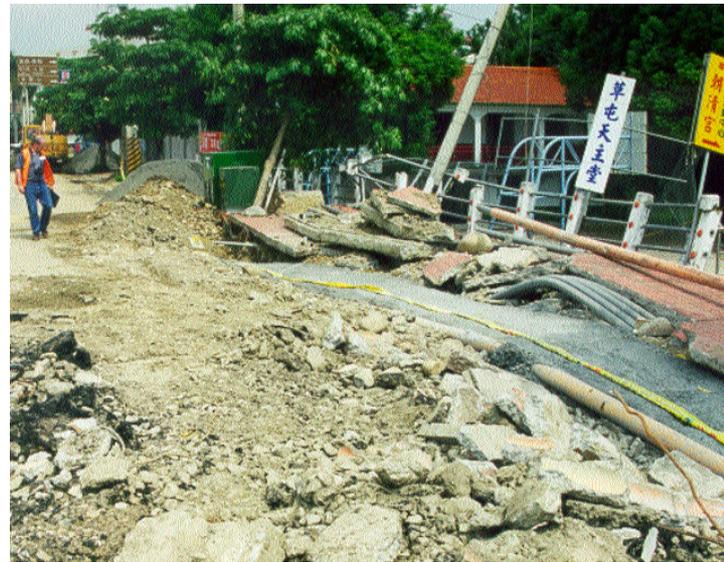
Figure 2.12. Lifeline services can be destroyed where they cross the fault rupture as illustrated by service pipes disrupted during the 1999 Taiwan Earthquake. Source: Dave Brunsdon.

Lifelines crossing the fault can break and be rendered unserviceable (Figure 2.12). This can delay emergency responses and may compound recovery throughout the area affected by the earthquake.

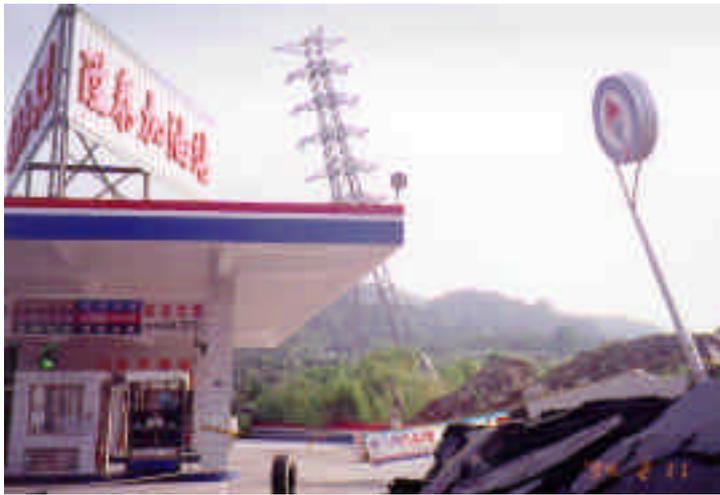
Figure 2.13. Damage due to fault rupture is limited to the area of fault rupture as illustrated by the undamaged petrol station next to a fault that ruptured (to the right of the photo) during the 1999 Taiwan Earthquake. Note the lean on the power pylon. Source: Dave Brunson.

Surface rupture is usually restricted to earthquake faultlines, and hence occurs in known locations. Buildings and services straddling the fault line can be destroyed, but structures next to the fault may remain unscathed despite near-fault effects and intense ground-shaking (Figure 2.13). Although fault traces can be mapped, there is a chance that unmapped faults may re-activate or new faults may appear.

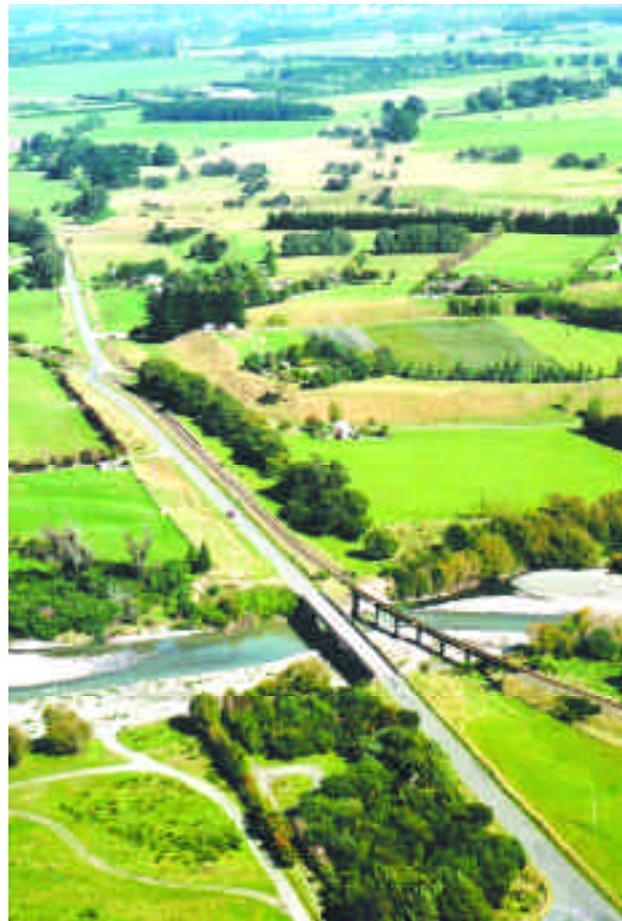
Figure 2.15. Double Bridges, Opaki. The active Mokonui fault crosses the road and the rail line close to the rail crossing in the distance.

Several faults with the potential to rupture are present in the Wairarapa (Figure 2.14). The main faults that cross the Wairarapa's major engineering lifelines are the Wairarapa, Carterton, Masterton, and Mokonui (Figure 2.15) faults. Of particular concern is the Masterton fault, which runs through the centre of Masterton. Since fault rupture is a localised hazard restricted to ground damage around the fault, offshore faults and faults outside the Wairarapa are not a fault rupture hazard to the Wairarapa's lifelines. The only reported fault rupture event in the Wairarapa was during the 1855 earthquake (Figure 2.16). The Wairarapa fault ruptured over a distance of approximately 72 km. Immediately following the earthquake there were many reports of vertical displacement of the fault. All reports indicate that the Rimutaka side of the fault was uplifted relative to the Wairarapa valley floor.

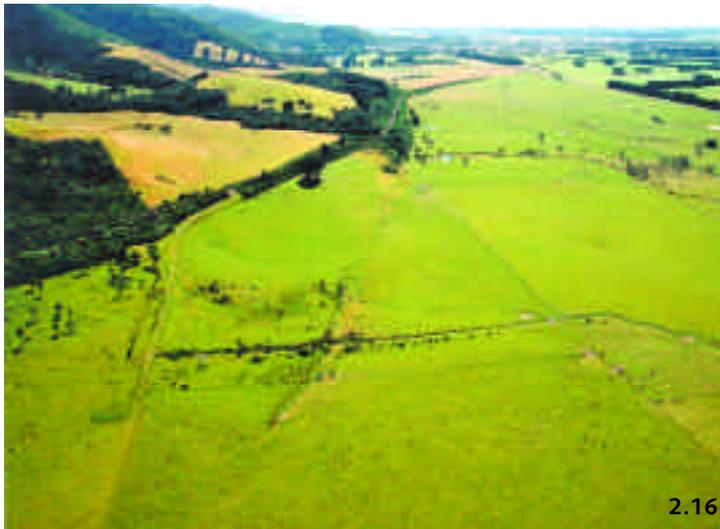
2.16

Figure 2.16. The Wairarapa fault, Western Lake. The Wellington to Woodville railway traverses the fault scarp in the centre of the photograph. The fault is evident in the foreground.

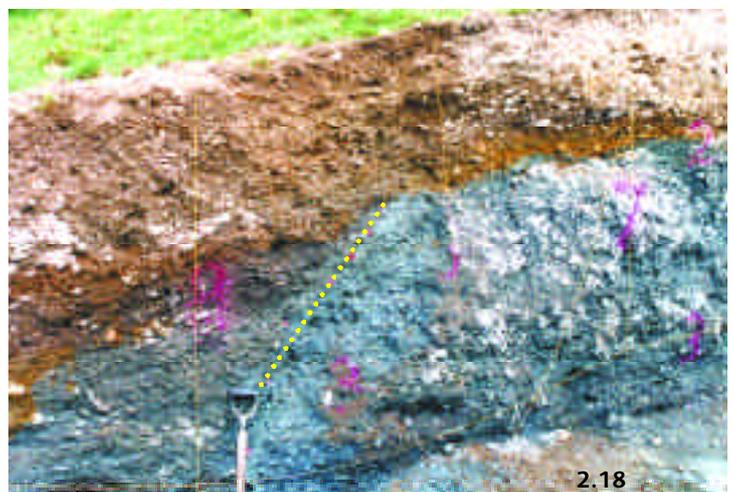
2.18

Figure 2.18. Trench near Cobden Road exposing displaced units and revealing the Carterton fault. The position of the fault is marked by the dotted line.

The study was a follow-on from Zachariassen (2000) and was undertaken to better understand the geological context and slip rates of the faults. The study involved fault trenching to determine the structural style of the faults and provide information on past individual earthquake events (**Figure 2.18**). A trench across the

The trench near Cobden Road on the Carterton Fault revealed datable material in the late Holocene part of the trench which allowed discrimination of at least two late Holocene rupture events. These results are presented in Table 2.6. A slip rate of two millimetres per year and average single event displacement of two metres was estimated for the Carterton Fault. These estimates yielded a return period of 1000 years.

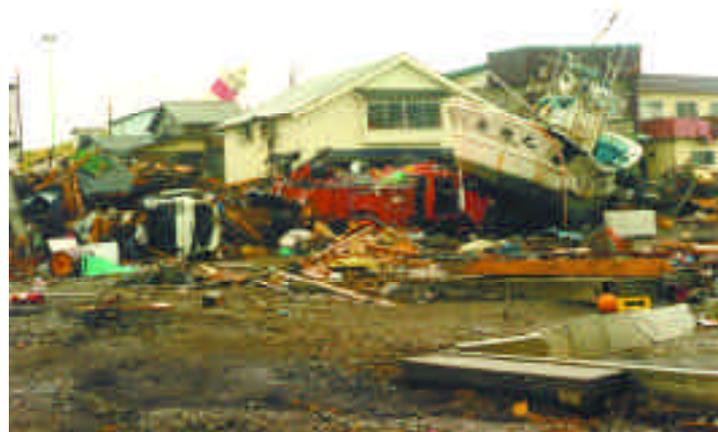
Figure 2.19. Damage following the 15 to 30 metre tsunami hit Okushiri Island in Japan in 1993. A large fishing boat was carried inland and deposited against a fire engine. Note the toppled lighthouse in the background. *Photo George Butcher.*

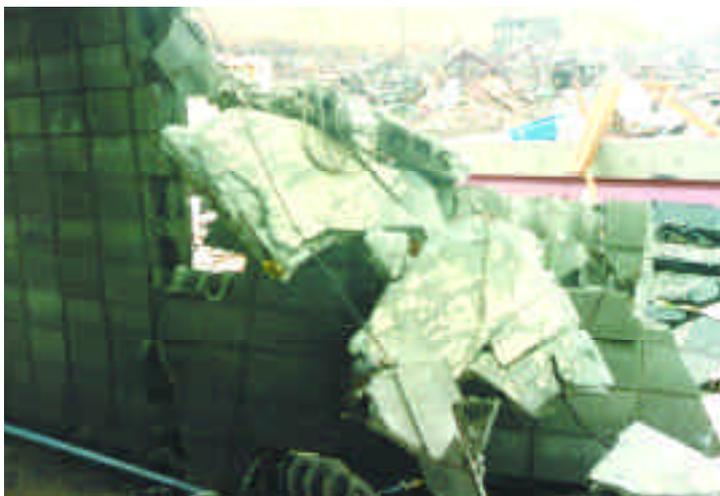
Figure 2.20. Reinforced concrete block wall destroyed by the 1993 Okushiri tsunami. Much of the damage in the background was caused by fires following the tsunami. Photo George Butcher.

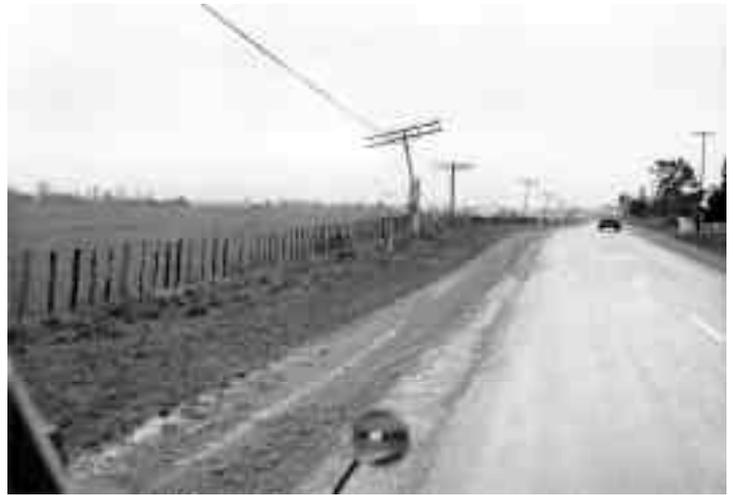
Figure 2.27. On the Masterton-Castlepoint Road at Te Ore Ore, telephone poles snapped during the Wahine Storm, April 1968.

Between 8-12 April 1968, ex-tropical cyclone Giselle (also known as the Wahine Storm) passed to the east of the Wairarapa. Wind gusts of up to 213 kilometres per hour were reported at Cape Palliser. Wind speeds along the Wairarapa's east coast were less severe, with gusts to 59 kilometres per hour recorded at Castlepoint. However, strong winds on the Masterton-Castlepoint Road at Te Ore Ore, snapped several telephone poles (**Figure 2.27**).

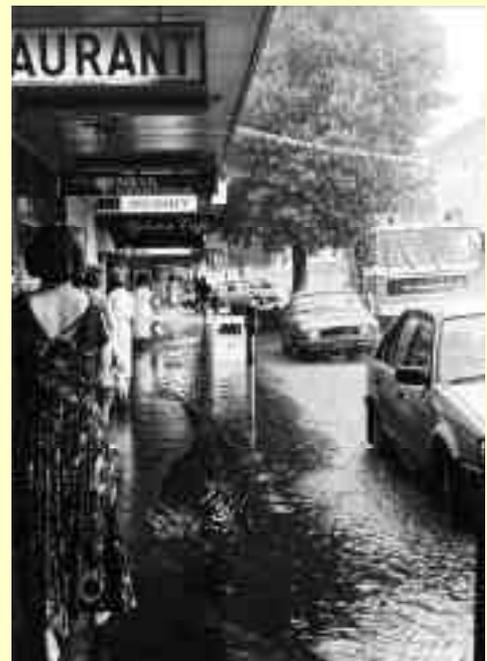
Figure 2.34. Surface flooding in Queen Street, Masterton during the 1993-94 flood. *Source:* Wairarapa Times-Age.

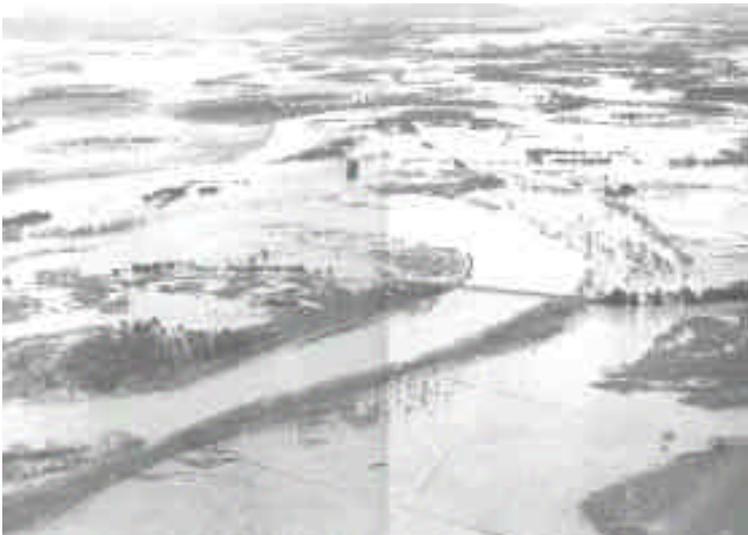
Figure 2.39. Waihenga (Martinborough) Bridge and Tawaha Settlement, looking downstream 18 hours after the flood peak on Sunday 29 June, 1947.

Early Wairarapa newspapers report the repeated flooding of Masterton and Greytown, while flooding in the Lower Wairarapa Valley was a significant issue until the flood protection scheme was completed in 1983. (See **Figure 2.37 and 2.38**) During the 1947 flood, 20,000 hectares were inundated for many days with severe stock and productive losses (**Figure 2.39 and 2.40**).

(The 1947 flood recorded a peak flow of 2044 cubic metres per second at Waihenga Bridge and was calculated to have a 100 year return period. The second large flood of November 1994 flood had a peak flow of 1819 cumecs and a 50 year return period).

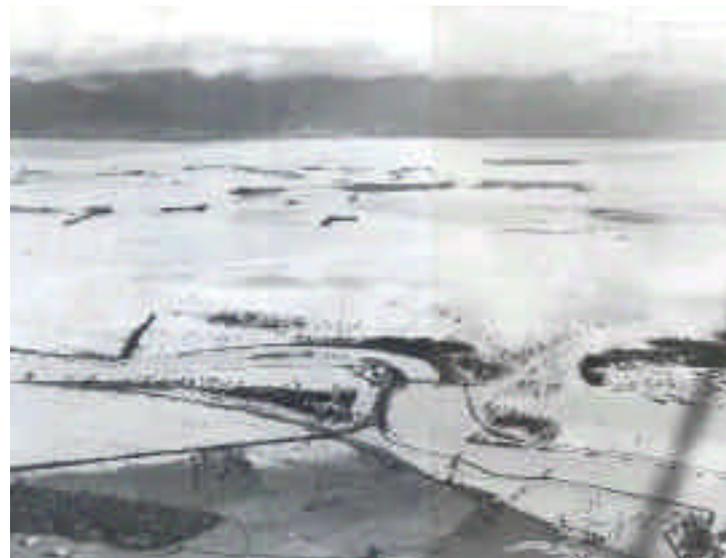
Figure 2.40. Lower Wairarapa Valley looking west over the Tuhitarata (Lower Valley) Bridge during the June 1947 floods.

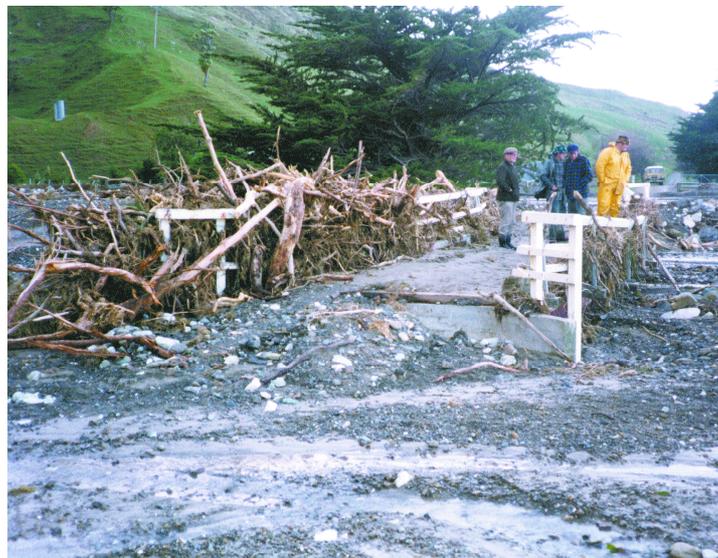
Figure 2.42. The Waimoana Bridge after the June 1981 flood. The bridge had a clearance of eight feet when built.

The high coastal ranges can have an adiabatic effect under such easterly conditions. Over the years a number of localised, severe flood events have occurred under such easterly conditions with extreme localised damage to roads and bridges. The Kaiawhata and Flat Point areas were devastated by such a storm in 1981 (**Figure 2.42**).

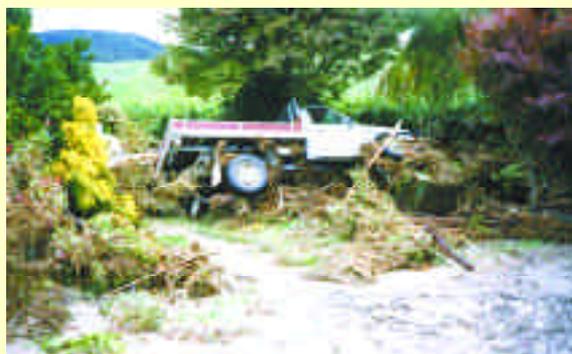
Figure 2.41. Vehicle lifted onto hedge by the 1991 flood waters.

Even with its long history of flooding, Tinui was completely taken by surprise by the savageness of this flood. The speed with which the village went under water and the depth of water inside houses and businesses shocked long-time residents. Floodwaters entered five houses, the school, two shops, a church and the hotel. Communications were lost for 12 hours, the electricity substation was flooded and failed, and there was widespread road damage.

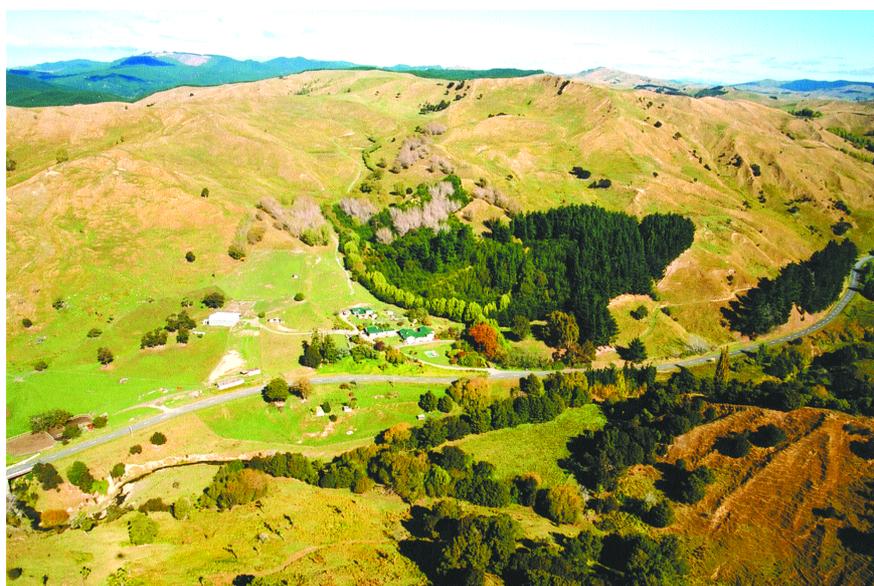
Figure 2.47. The Te Maire slump, Masterton-Castlepoint Road is typical of many deep-seated landslides in the Wairarapa. This vast landslide recommenced movement following the very wet 1977 winter, threatening to close the road, destroy houses and create a large lake. Extensive earthworks, drainage, planting and stream control were necessary to eventually stabilise the movement.

Extensive rainfall triggered landsliding occurred in the Wairarapa in 1924, 1932, 1941, 1947, 1953, 1961, 1977 and 1991. **Table 2.10** details some of the effects of those storms. Pre-existing deep-seated, slow-moving failures can be re-activated following heavy rain events, and several such examples can be found in the Wairarapa. **Figure 2.47** shows a large deep-seated landslide on the Masterton-Castlepoint Road which threatened to close the road after the heavy rain experienced in 1977.

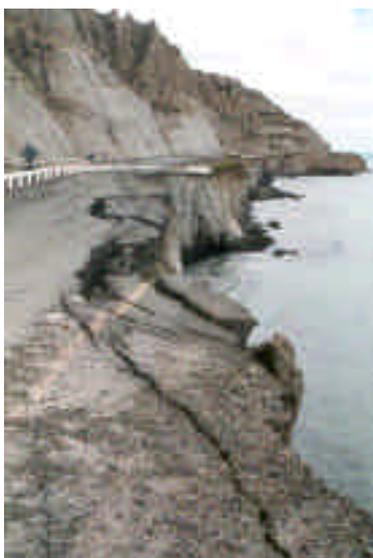
Figure 2.49.

Whatarangi, Cape Palliser. Erosion of the mudstone material by the sea is forcing the road landward with each new phase of erosion. There is no longer anywhere for the road to be relocated and coastal protection works are being put in place to reduce the rate of recession.

Much of the Wairarapa coast is in a state erosion and there are several locations where erosion is significant and affecting engineering lifelines. These areas include Palliser Bay (**Figure 2.49**), Riversdale, Castlepoint and Mataikona. The lifelines at risk include the roads and any infrastructure that follows the road line.
