## CHAPTER 5. ENERGY - CONTENTS

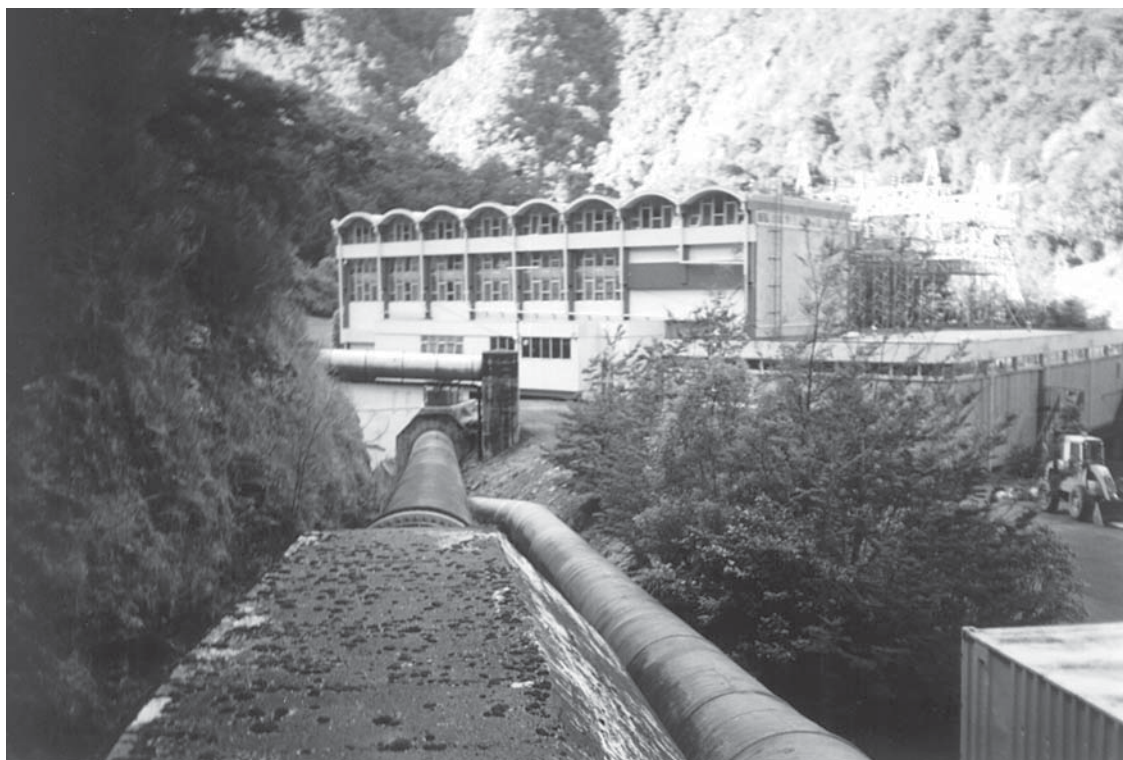
*Penstock System Waipori 2A Station - Waipori Power Generator Ltd*

The system can pass operational flows up to 36.8 cubic metres per second under a net head at the turbine inlet valves of approximately 178m. The recorded total generation output from 2A Station under maximum operational flow conditions is 57.5MW.

The intake to the No.2 tunnel is fitted with three rectangular cast iron gates and the No.1 tunnel is fitted with a cast iron butterfly valve at its upstream end. The intake gates and butterfly valve are not used to control flows through the system but are primarily used to exclude water from entering the tunnels from No.2 lake during maintenance or inspection work.

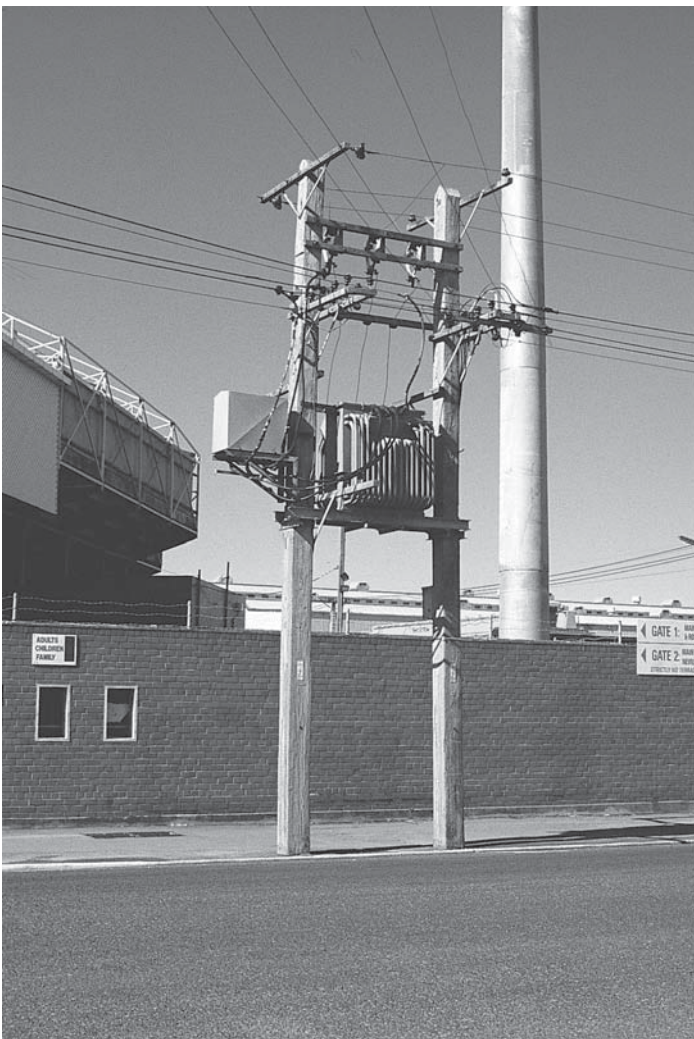
*Typical Pole Mounted Transformer - Civil Defence*

Individual service lines of 33kV and 11kV are duplicated where they are critical to the network elements and the service area is significant, but some local damage may occur due to earthquake shaking of pole mounted transformers.

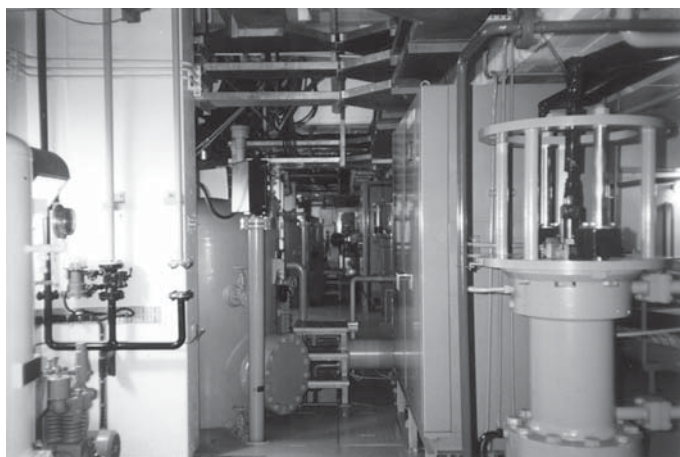
*Interior, 2A Station, Waipori - Waipori Power Generation Ltd*

In general, the plant and equipment within the power house for the 2A and 1A power stations was specified to meet earthquake conditions corresponding to a horizontal acceleration of 0.75g. It is therefore extremely unlikely that any material damage will occur to the equipment itself as a direct result of the earthquake movements. Some short term disruption may result. Some disturbance to mechanical protection devices may occur as a result of "shaking". Minor damage to the building fabric or fittings may also lead to some

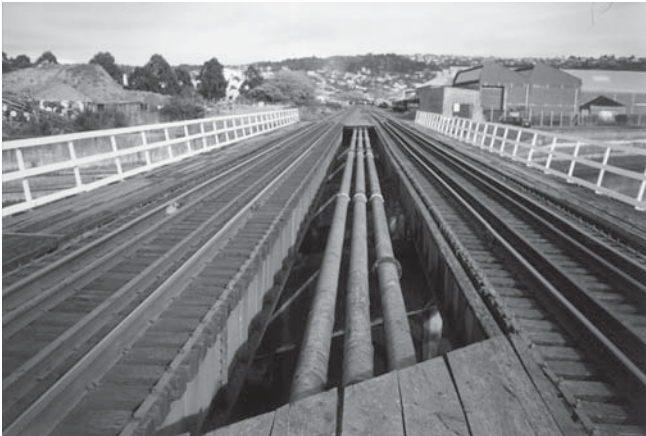
*Oil Pipelines from Oil Wharf to Storage Tanks Crossing Leith Rail Bridge - BP Oil Limited*

Potential damage may occur to pipelines crossing the Leith Bridge which is a common carrier for other service pipelines. Any failure here will almost certainly be fracturing of the pipelines due to bridge displacement rather than to inherent pipeline condition.

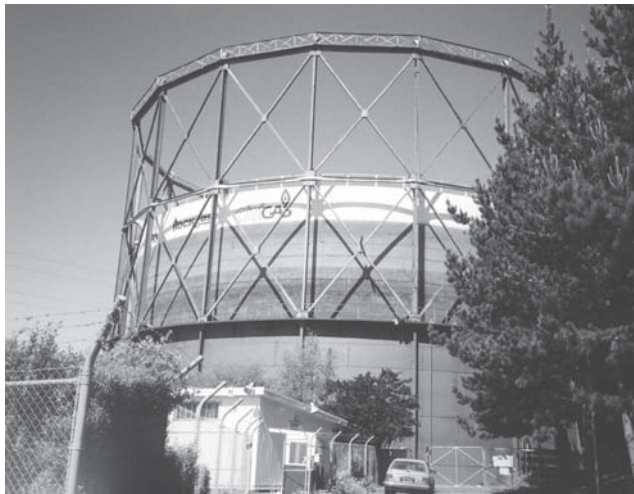
*Kensington Gasometer - Citigas Limited*

It is therefore difficult to present a case for other than replacement of significant lengths of pipeline, particularly as most sections of the principal gas main have no redundancy. It is considered, however, that progressive replacement of the most vulnerable elements may be a more acceptable course of action. Indications are that the 400mm diameter main line from the tempering plant to the Kensington gasometer, and the gasometer itself need priority treatment.

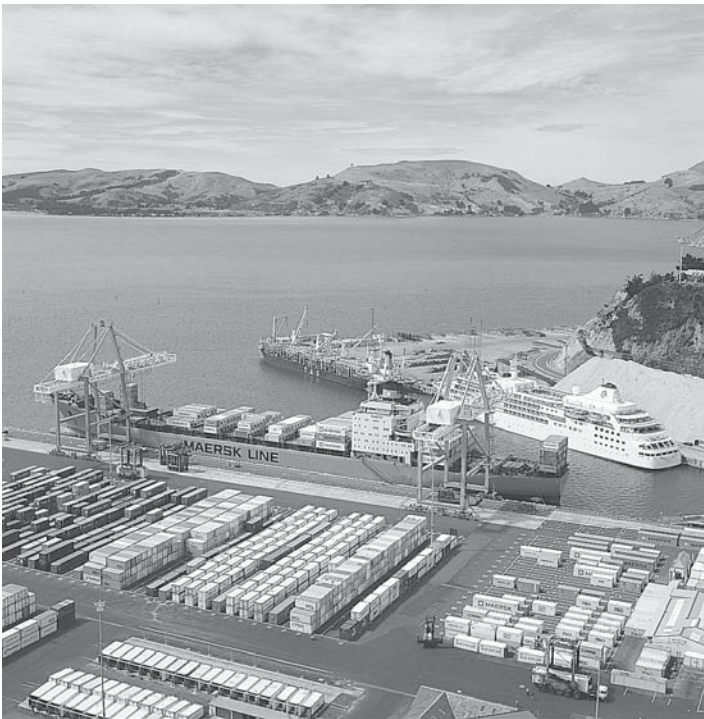
*Container Terminal and Beach Street Wharf, Port Chalmers - Port Otago*

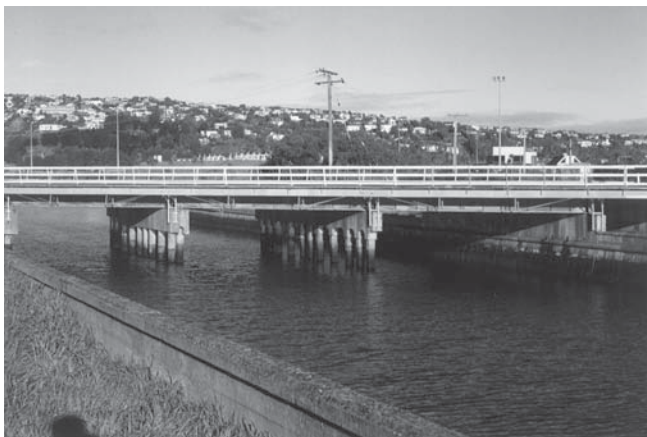
*Railway Bridge over Water of Leith - Civil Defence*
