CHAPTER 7. COMMUNICATIONS - CONTENTS

Telecommunications and Broadcasting

TELECOMMUNICATIONS - DESCRIPTION OF SERVICE

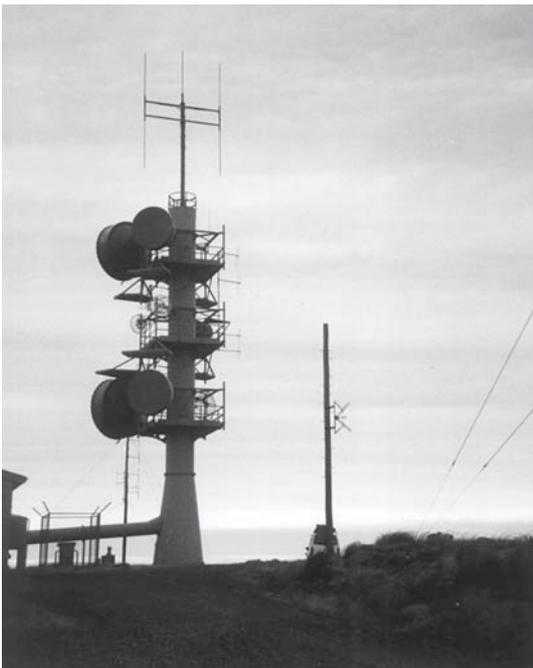
Microwave Transmission Site, Swampy Summit

Swampy Summit and Mt Cargill are the major microwave sites to and from the city and both sites have fibre optic cables connecting them to the local Dunedin networks. Mt Cargill also has local circuits to the TVNZ facility in Dowling Street to carry television programming. There is a further link to the BCL base in Albany Street carrying telephone and data traffic for the Maritime Safety Service, which has facilities located at Mt Cargill.

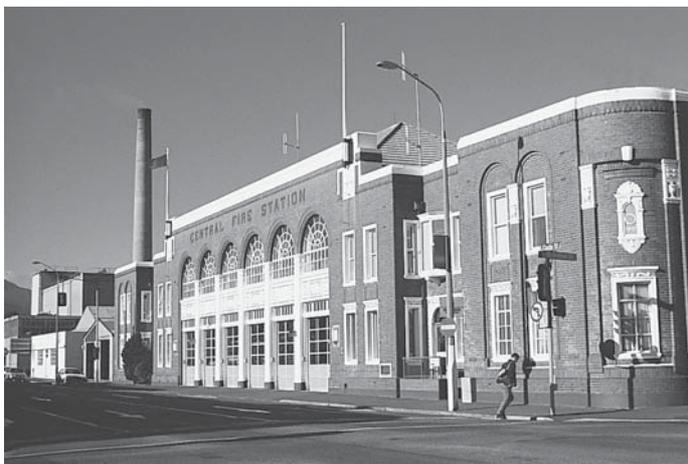
This building, although including reinforced and steel elements, is essentially of unreinforced masonry. It is likely to suffer severe damage appliances housed within the building may be damaged or trapped. There is also a risk to personnel.

Dunedin Central Fire Station - Civil Defence
