5.1 ELECTRICAL

(1) Powerco network

NETWORK DESCRIPTION

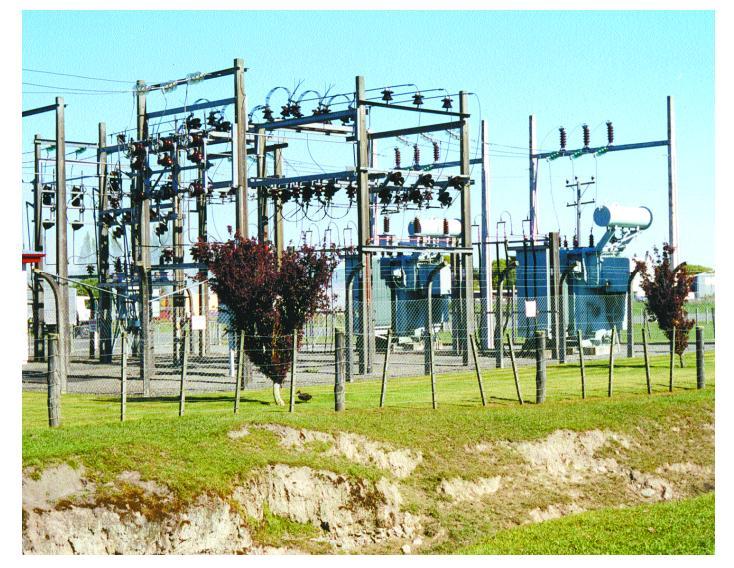
Figure 5.1. Powerco substation at Akura.

The Masterton GXP supplies 33 kV to Powerco's Chapel, Akura (Figure 5.1), Te Ore Ore, Clareville and Norfolk urban zone substations, as well as Awatoitoi, Tinui and Gladstone (Figure 5.2) rural zone substations. The Greytown GXP supplies 33 kV to Martinborough and Featherston urban zone substations as well as Kempton, Tuhitarata and Hau Nui rural zone substations.

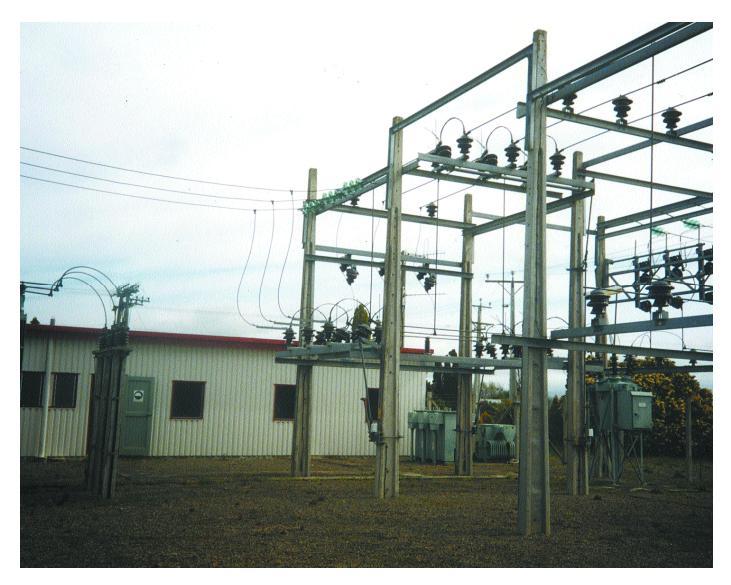
Figure 5.2 Powerco's rural substation at Gladstone.

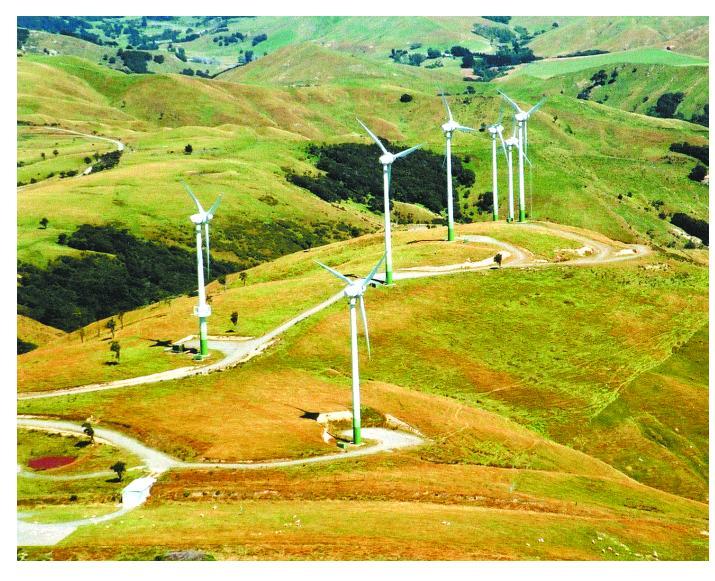
Figure 5.3. The Genesis Power Hau Nui wind farm, 21 km south east of Martinborough. Seven turbines generate 3.5 MW of power into the Hau Nui zone substation.

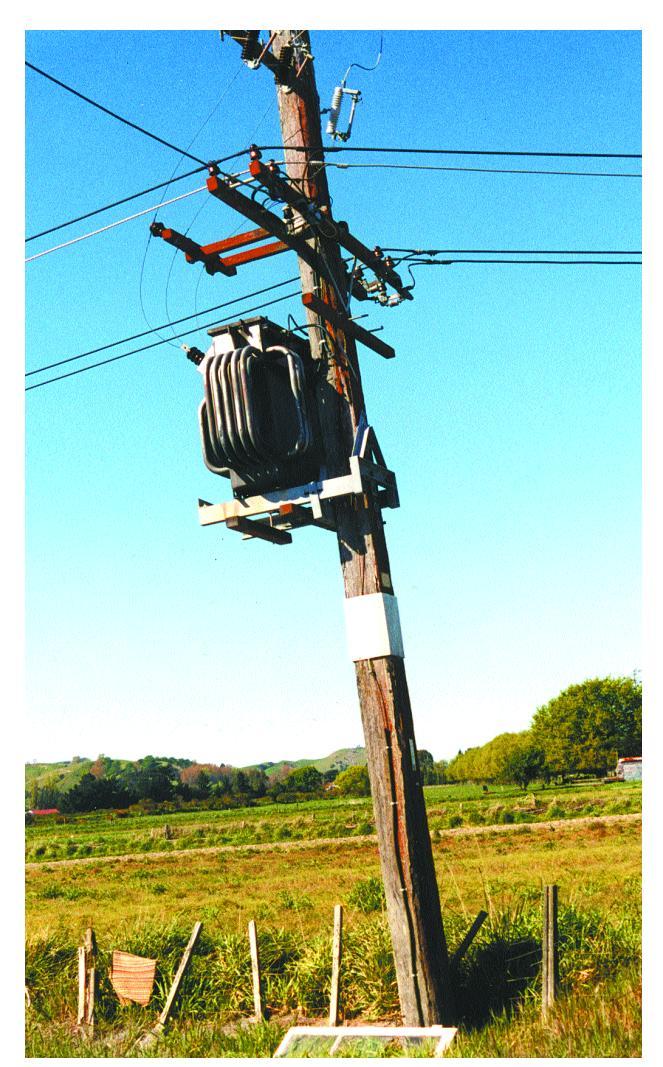
An example of a pole-mounted transformer is shown in **Figure 5.4.** Some transformers, as with this one at Te Ore Ore, are mounted on a single pole. The soils in this area have a liquefaction potential, which would result in a high level of risk for the installation.

Figure 5.4. Single pole-mounted transformer at Te Ore Ore. *Photo by George Butcher.*

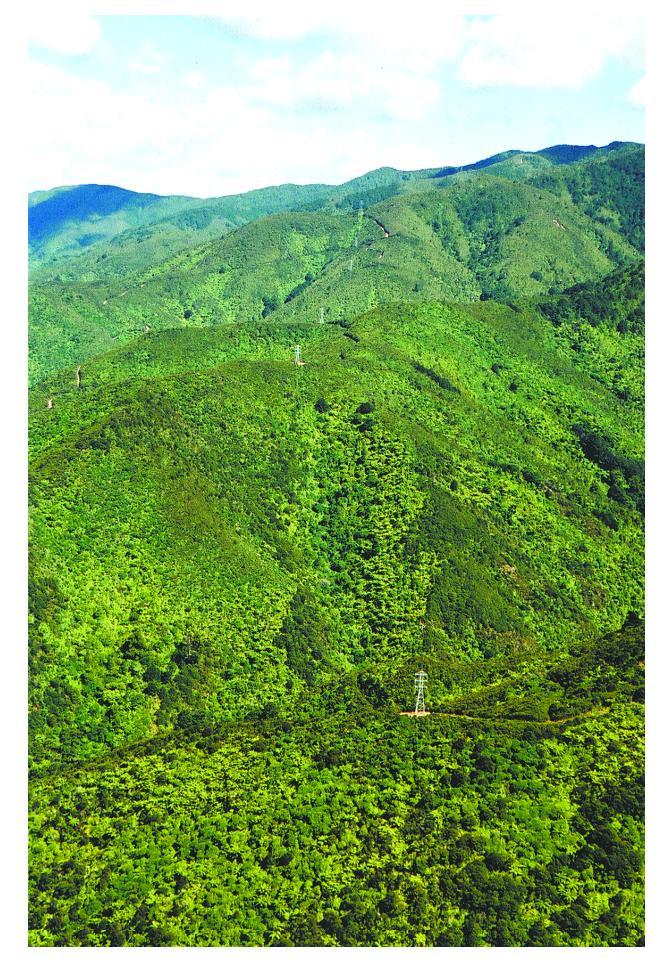
Figure 5.5. Transpower 110 kV Masterton-Upper Hutt line traverses the Rimutaka Ranges.

The Wairarapa region is fed at 110 kV from Upper Hutt substation via the Masterton-Upper Hutt A line, which is a double circuit tower line (Figure 5.5). Supply is also available at 110 kV from Woodville substation via the Mangamaire-Masterton A line, which is a pole line. The Mangamaire-Masterton line has a capacity to provide only about half of the Wairarapa Network maximum demand. Transpower operates substations at Masterton (Figure 5.6) and Greytown.

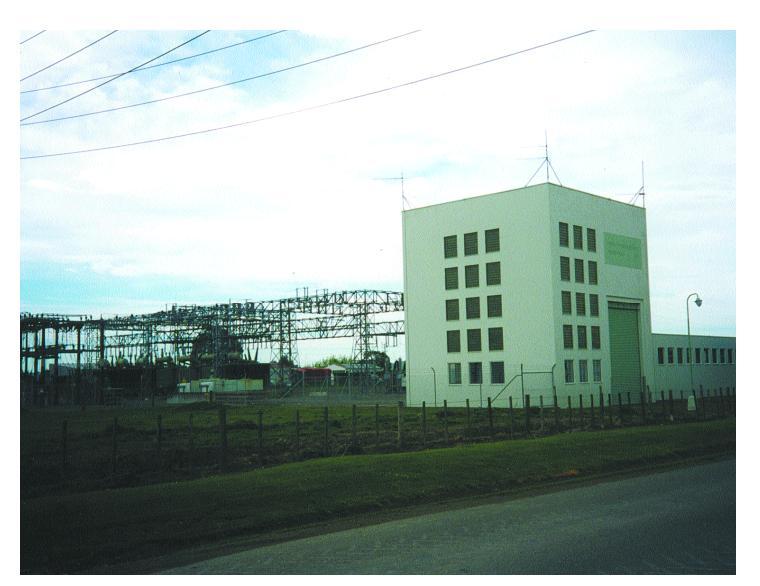
Figure 5.6. Transpower substation at Cornwall Rd., Masterton.

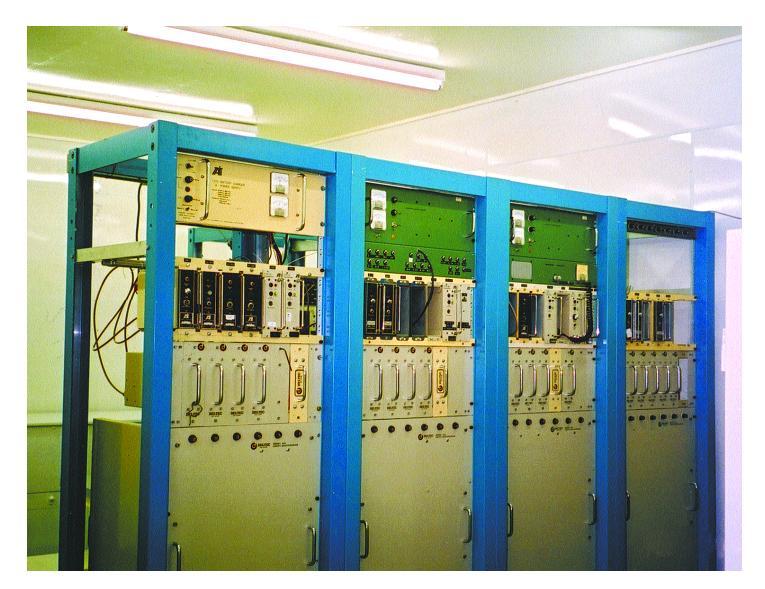
Figure 5.7. One of the equipment racks inside the Eringa transmitting site building.

Radio equipment, battery chargers, and other equipment are installed in standard aluminium racks with cables in ducts. The racks are about two metres high and are fixed to the floor slab with Dynabolts. Racks could be made more seismically stable if their tops were connected to the walls by struts. Chemsets for fixings are more reliable than Dynabolts and are preferable for important installations. The batteries in all three installations are well secured. All batteries have sufficient capacity to operate the equipment, under normal conditions, for five to six days without recharging.

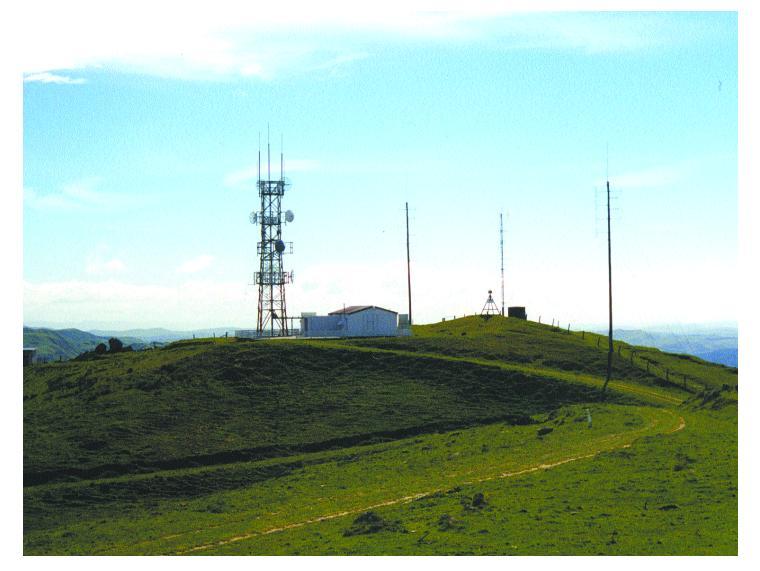
Figure 5.8. Transmitting and receiving towers at the Telecom Rangitumau site.
