# Cyclone Gabrielle Recovery Report | 06 July 2023

Reporting Period: 30/06/23 – 06/07/23

Weekly update on Cyclone Gabrielle recovery activity

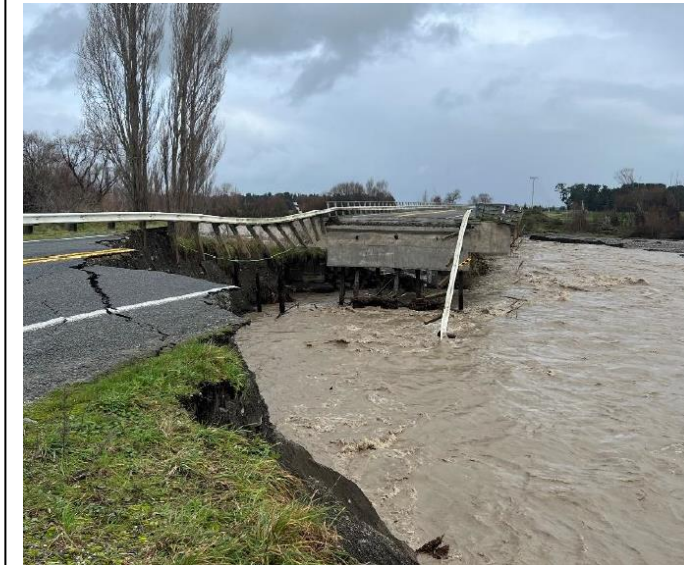
26 June 2023: SH50 at Waipawa bridge

- The road is closed while investigations into the most suitable repair methodology takes place for the washed out bridge abutment at the Waipawa river.
